Draft Monthly Report: March 2007

RBCAA

AQ002

8 May 2007

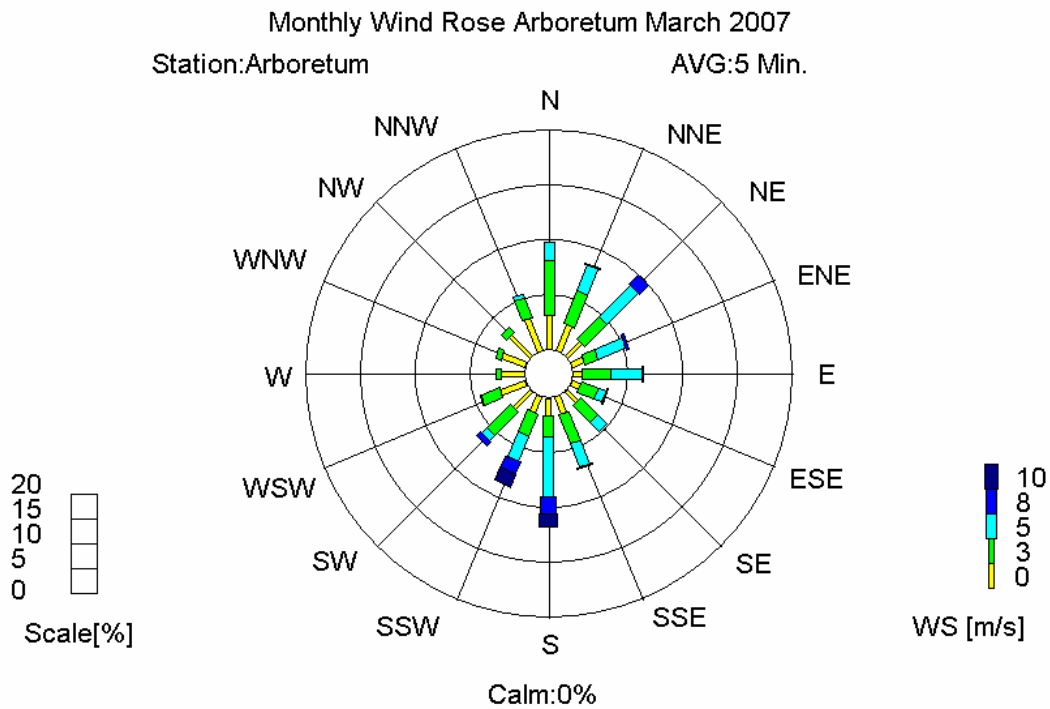
Wind rose for Arboretum for March 2007

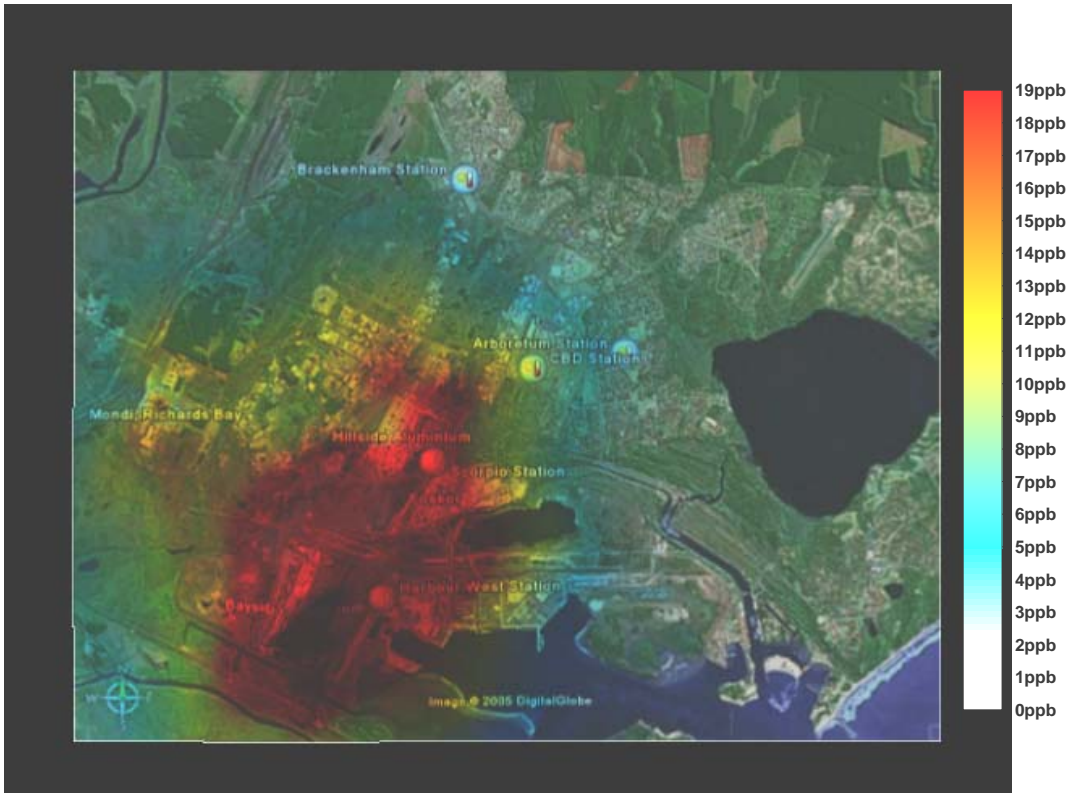
March 2007 Monthly Average SO₂ Concentration Dose Map (Concentrations in ppb)

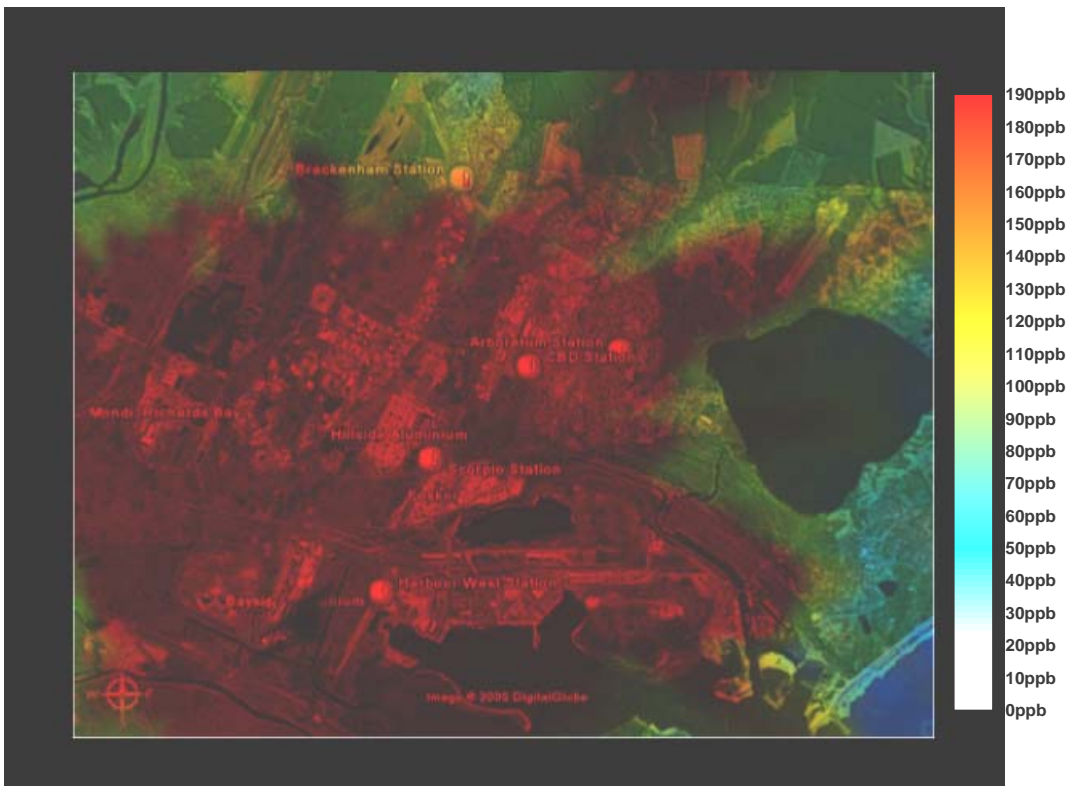
March 2007 Maximum 10 Minute Average SO₂ Concentration Dose Map (in ppb)

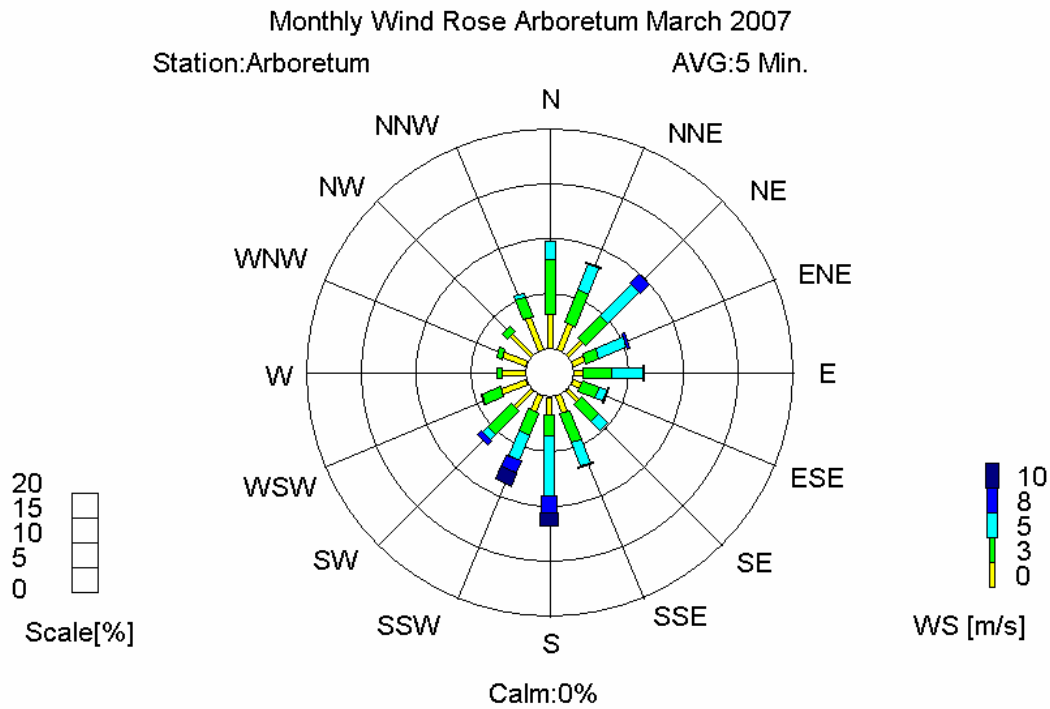
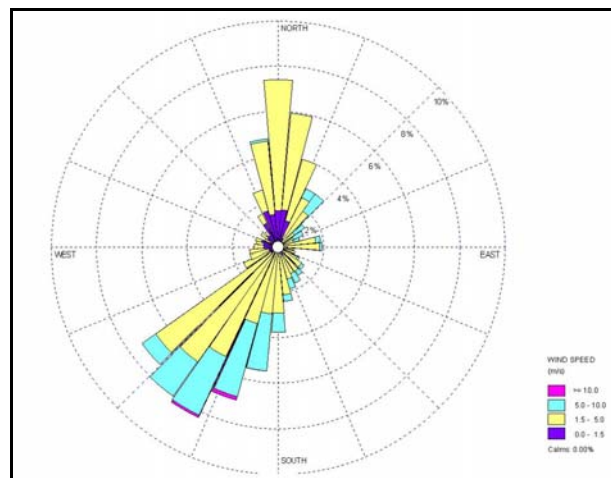
Figure 1: 5-minute average wind rose for the Arboretum station for March 2007, with comparison to the previous year.

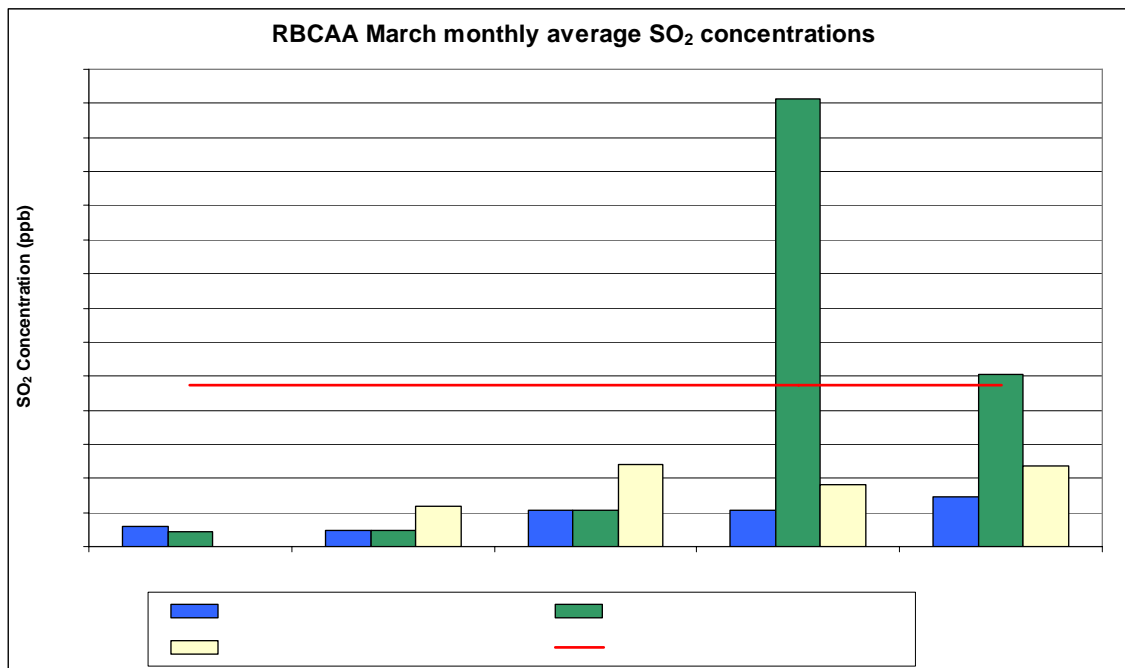
Figure 2: Monthly average SO₂ concentrations measured at fixed stations and comparison

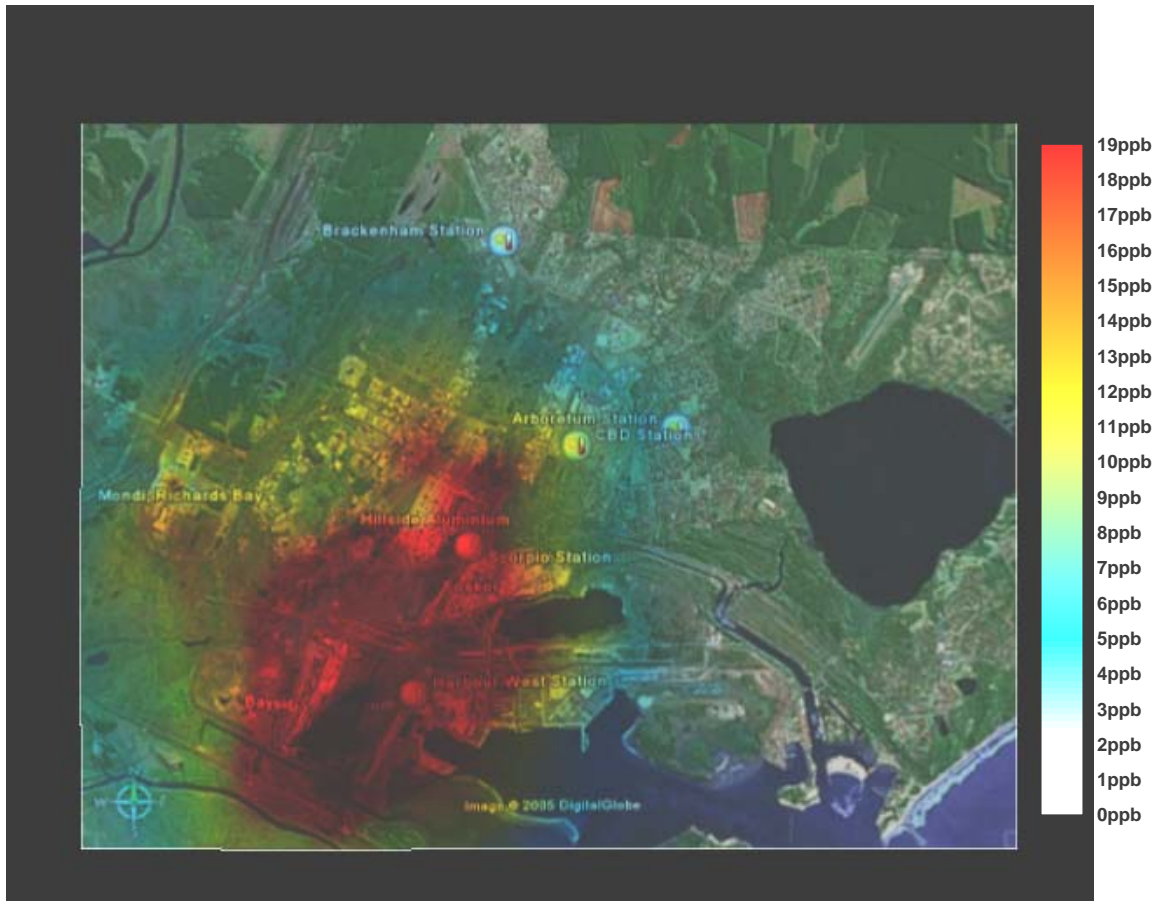
Figure 3: March 2007 monthly average SO₂ concentration dose map (Concentrations in ppb)

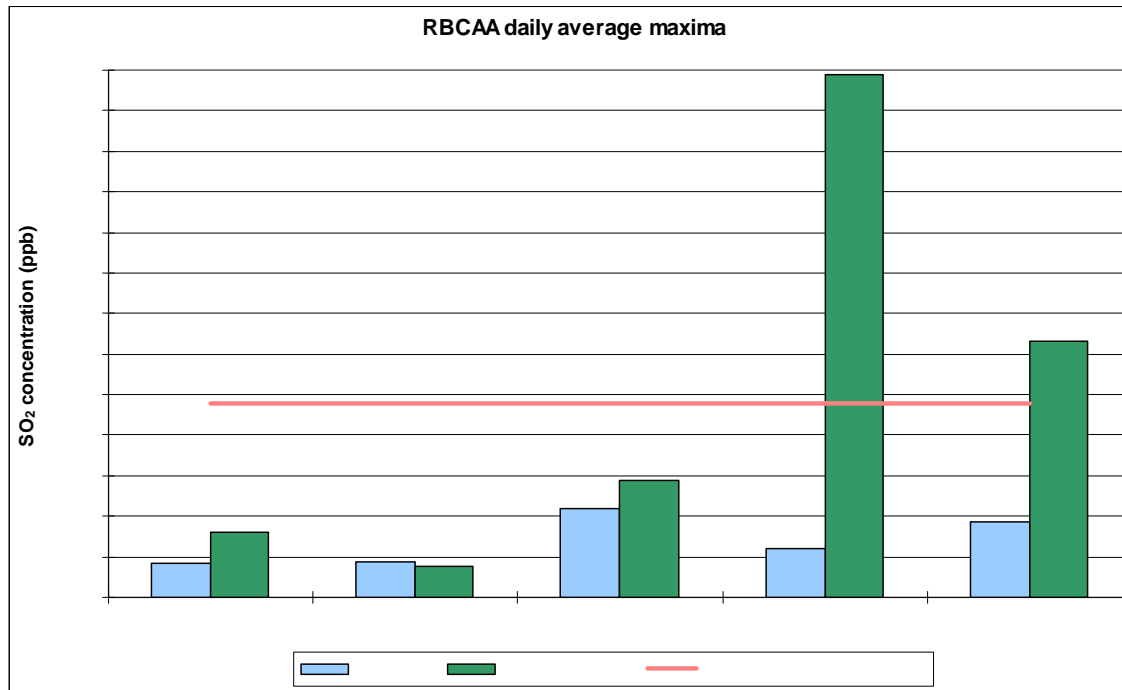
Figure 4: Comparison of Hawk predicted and measured maximum daily average SO₂ concentrations.

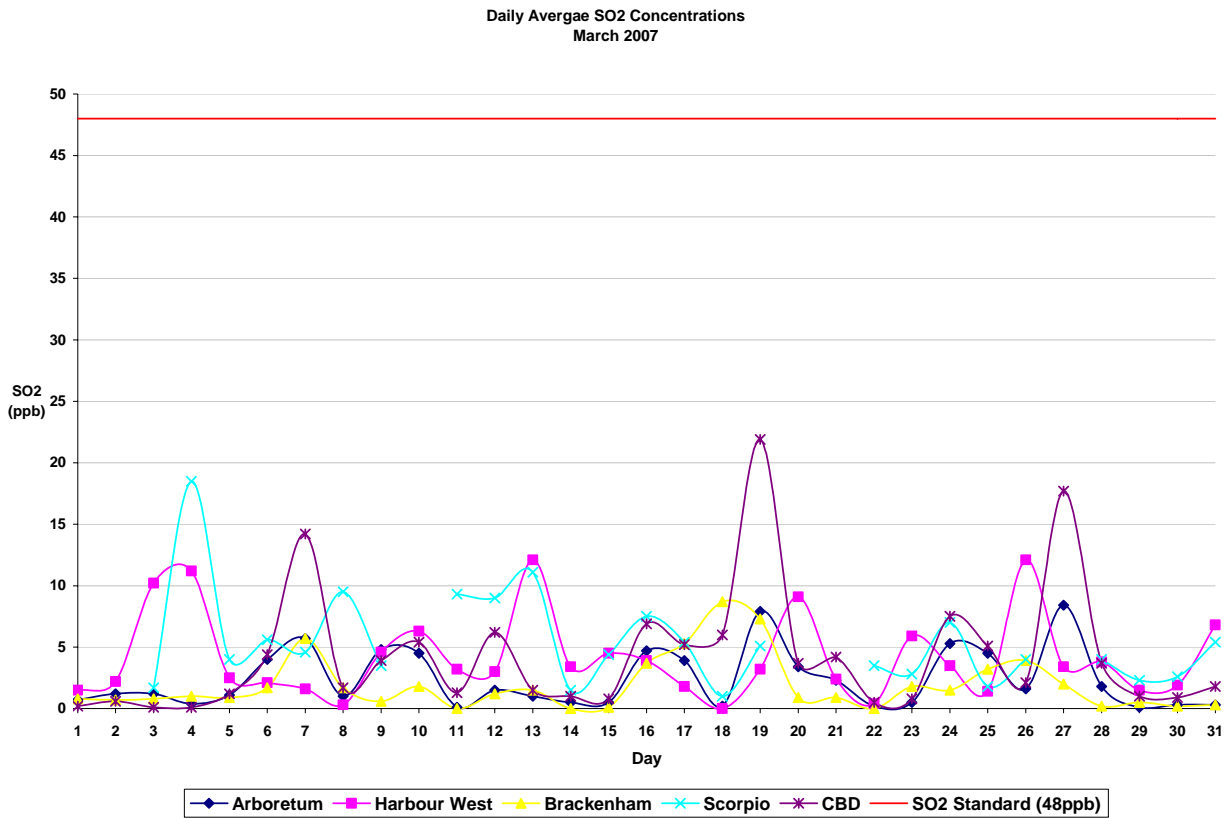
Figure 5: Daily average SO₂ concentrations measured at the fixed stations for March 2007
(National standard = 48 ppb)

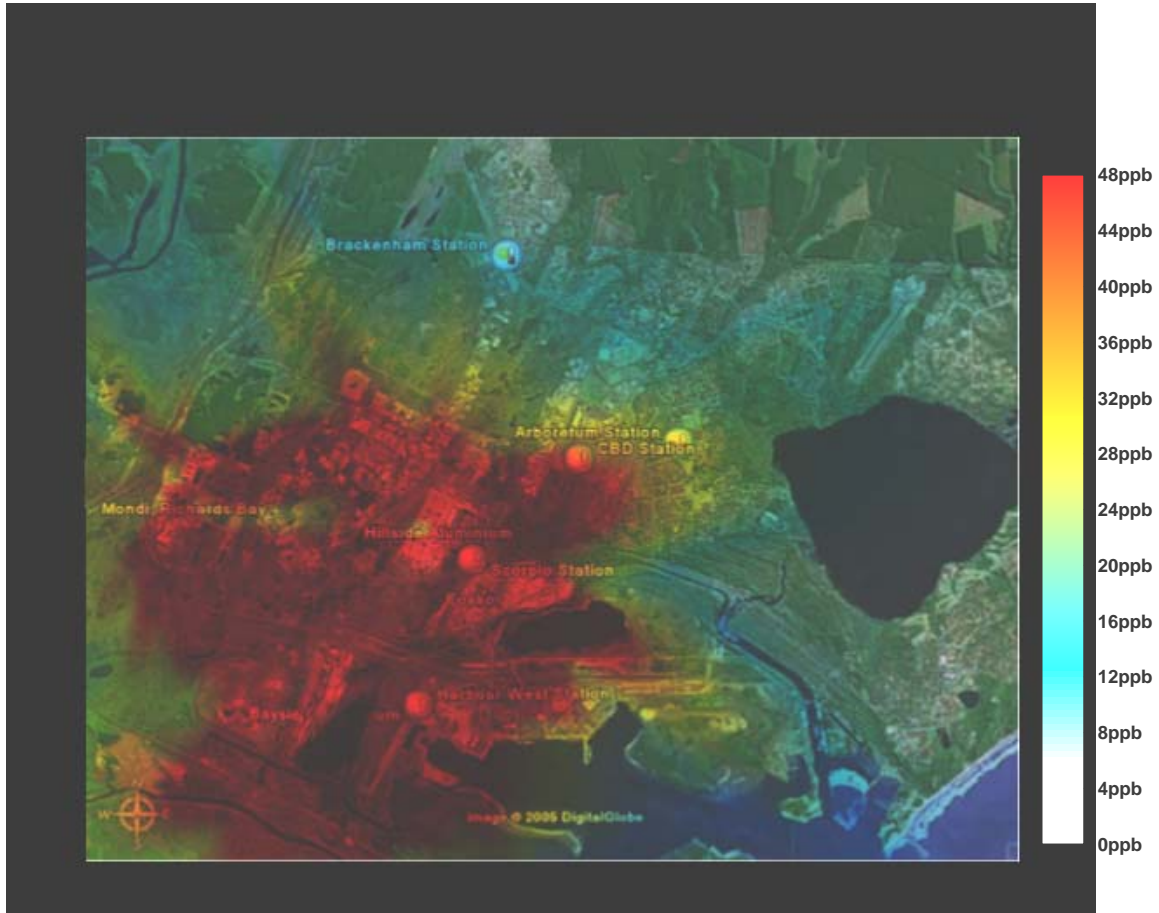
Figure 6: March 2007 maximum daily average SO₂ concentration dose map (concentrations in ppb).

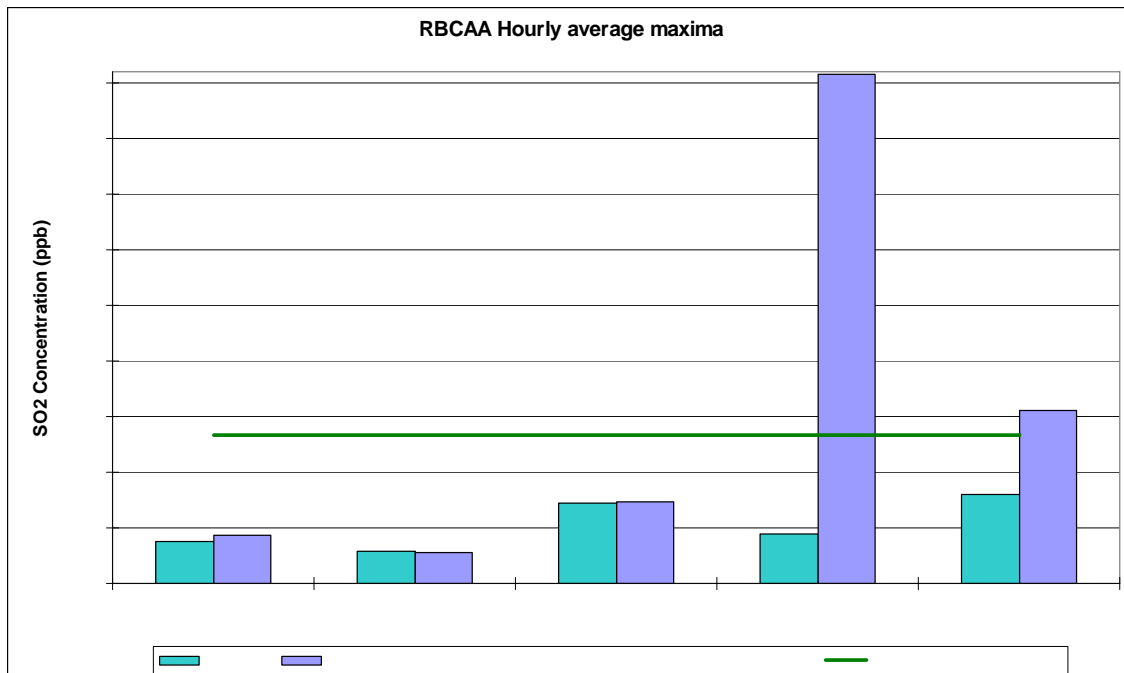
Figure 7: Comparison of Hawk predicted and measured maximum hourly average SO₂ concentrations during March 2007

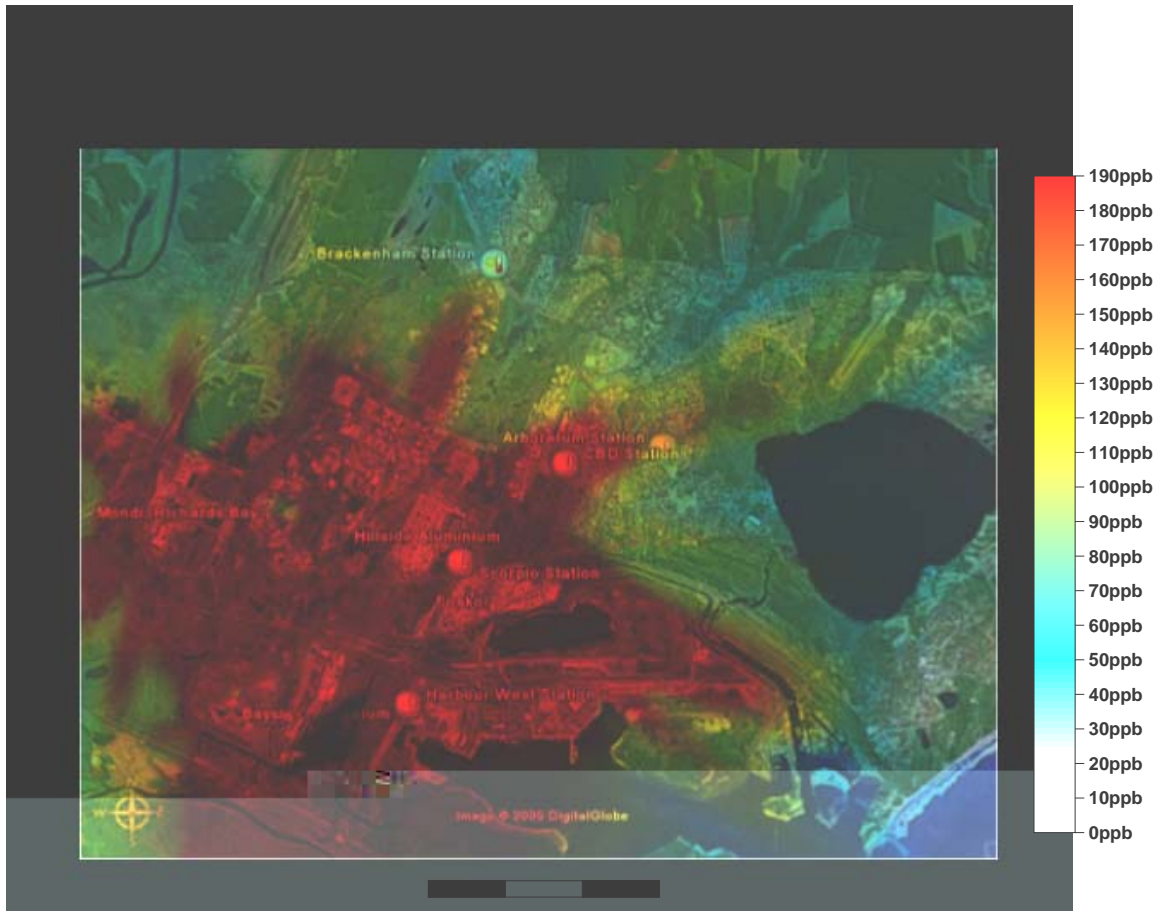
Figure 8: March 2007 maximum hourly average SO₂ concentration dose map (concentrations in ppb).

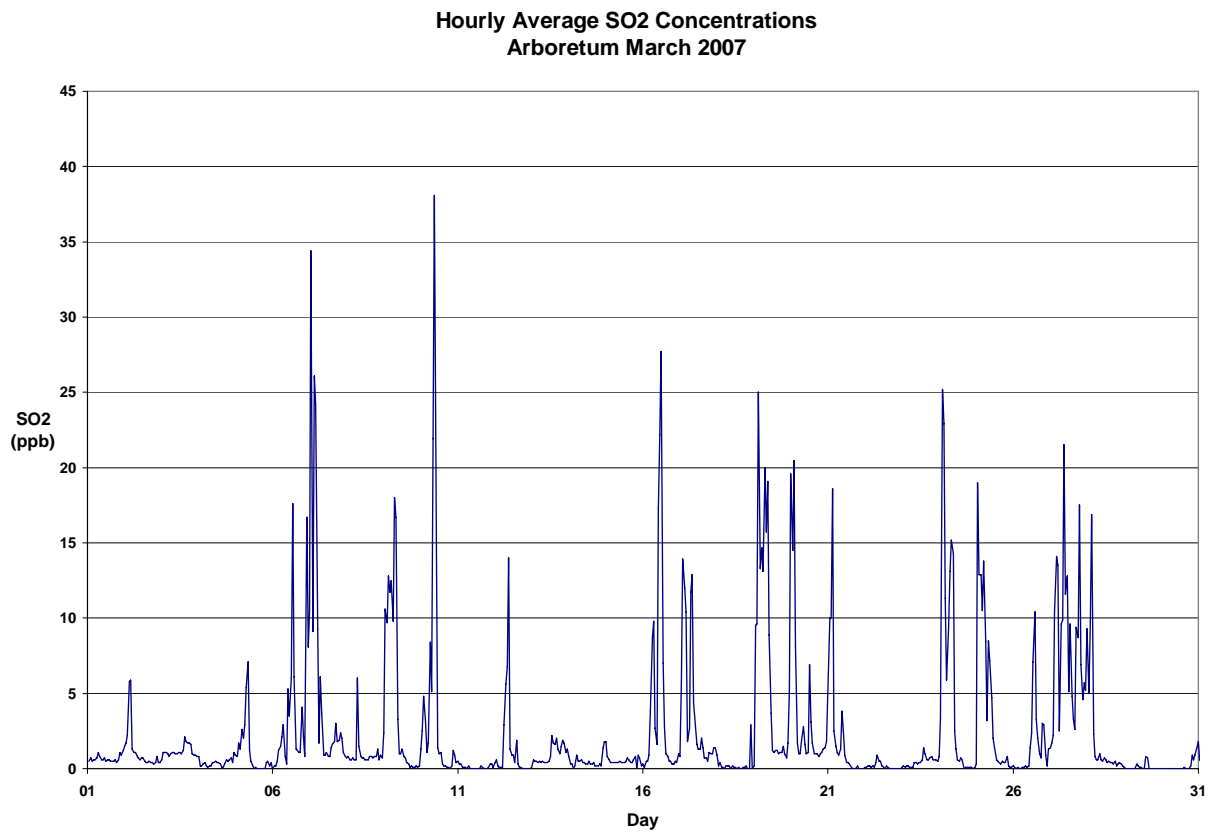
Figure 9: Hourly mean concentration at the Arboretum station (Monthly average = 2.3ppb)

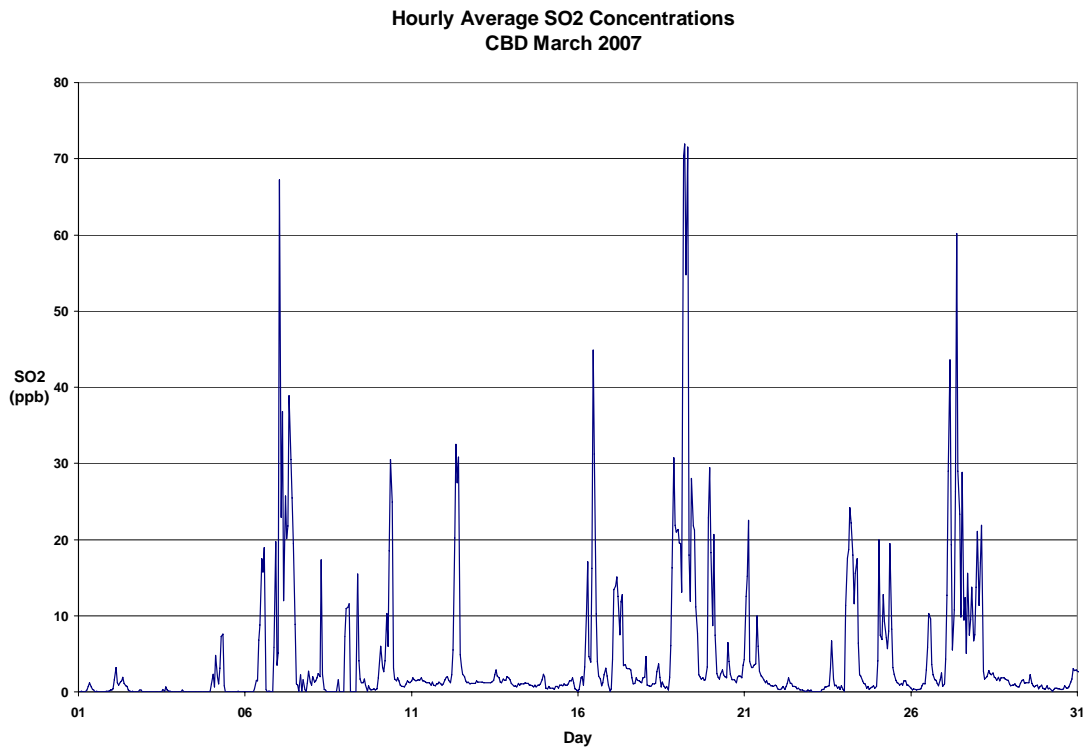
Figure 10: Hourly mean concentration at the CBD station (Monthly average = 4.2ppb)

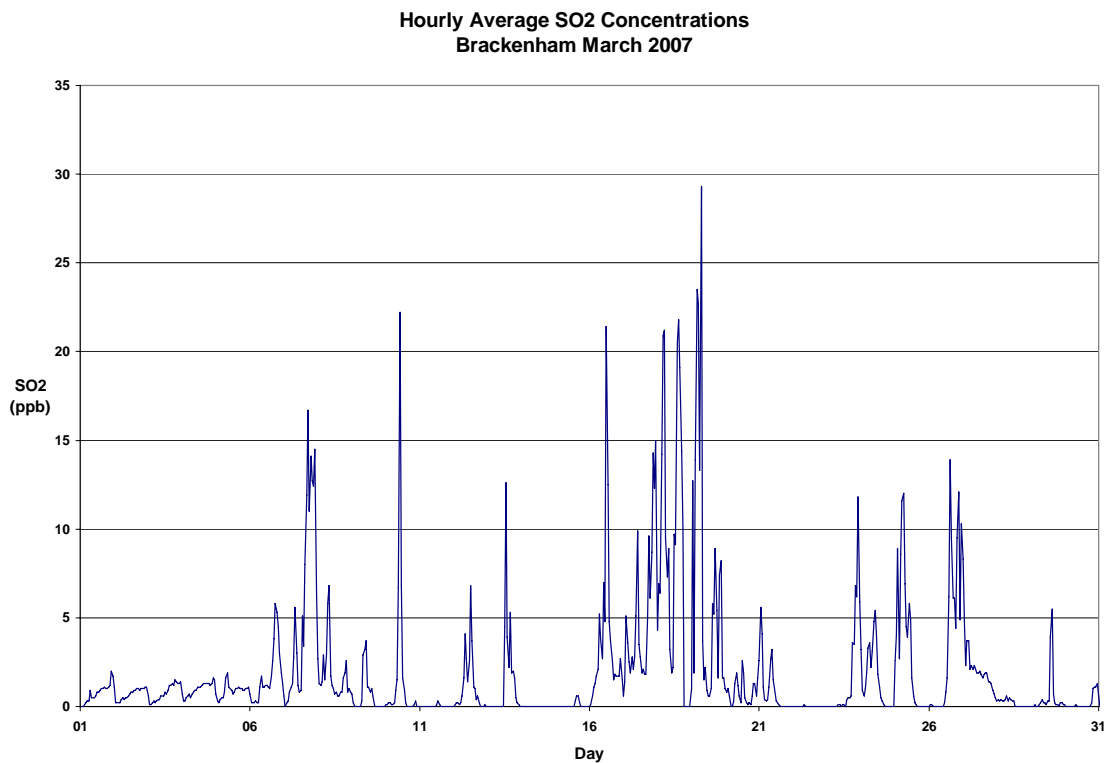
**Figure 11: Hourly mean concentration at the Brackenhams station (Monthly average = 1.9ppb)**

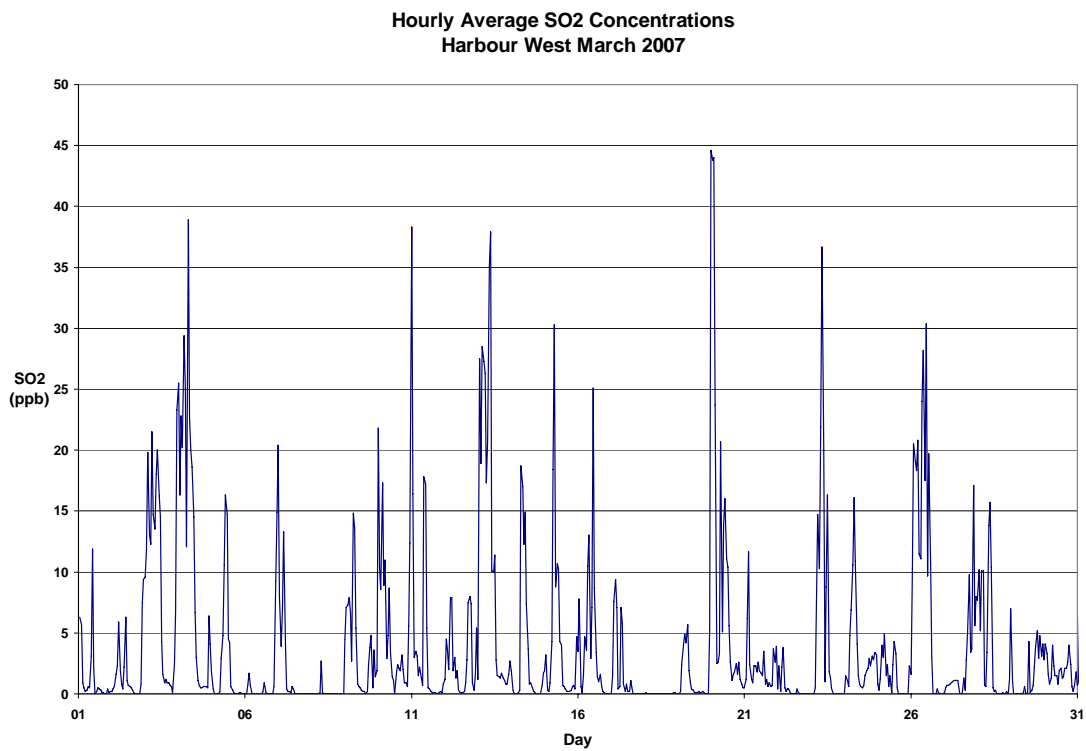
Figure 12: Hourly mean concentration at the Harbour West station (Monthly average = 4.1 ppb)

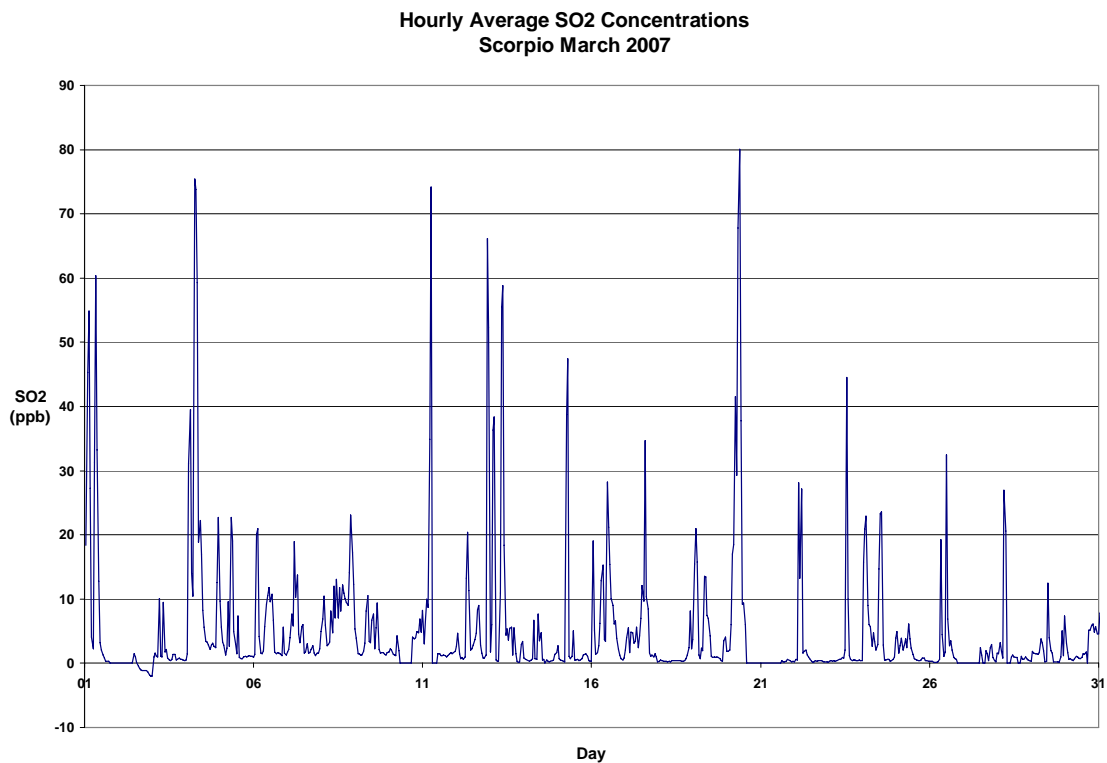
Figure 13: Hourly mean concentration at the Scorpio station (Monthly average = 5.7ppb)

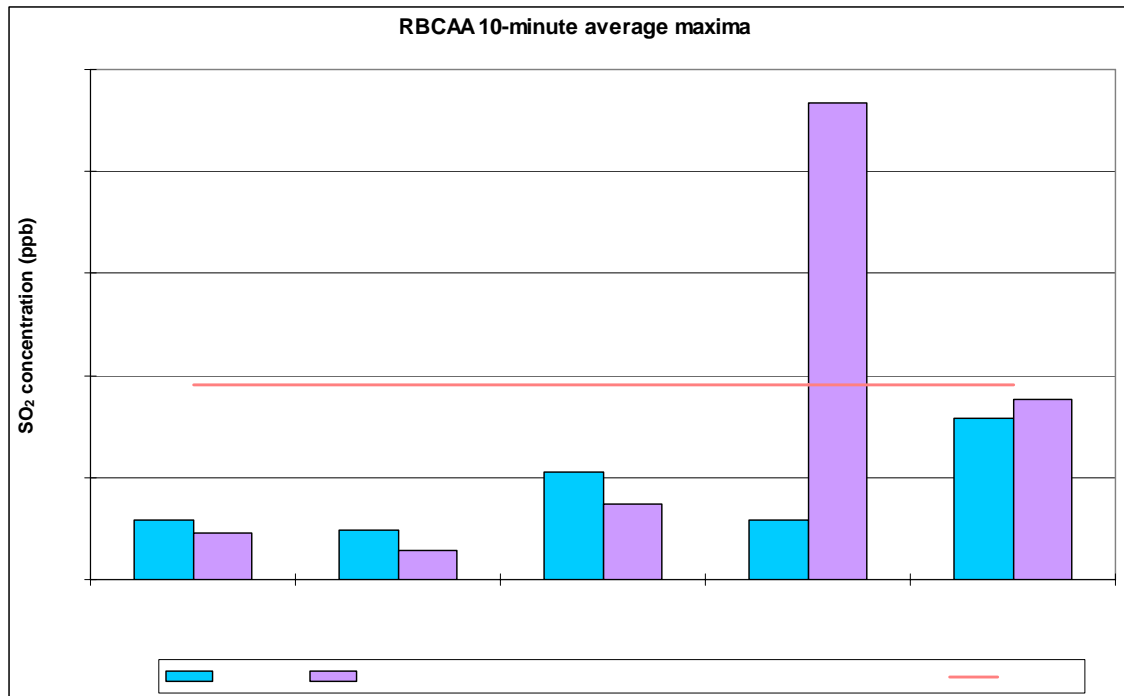
Figure 14: Comparison of Hawk predicted and maximum measured 10-minute average SO_2 concentrations.

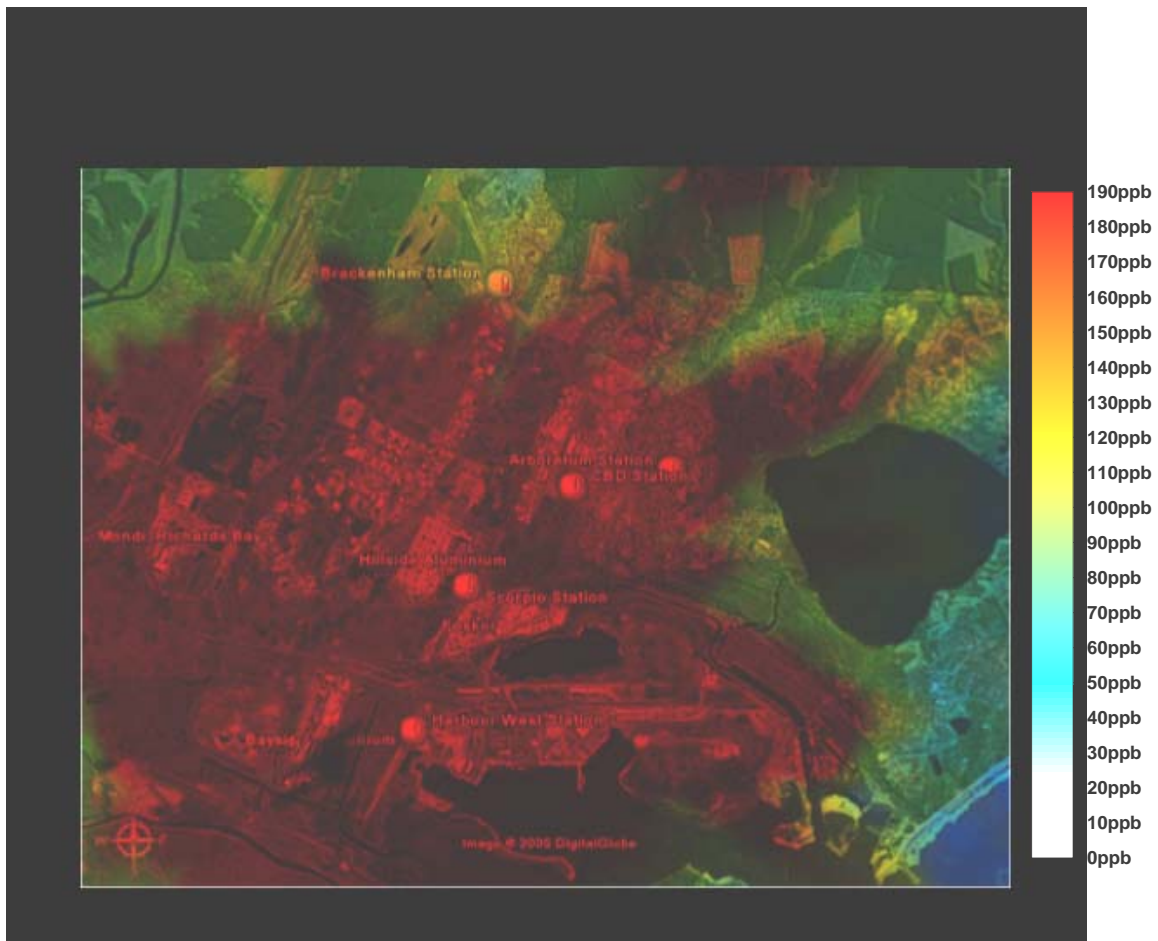
Figure 15: March 2007 maximum 10-Minute average SO₂ concentration dose map

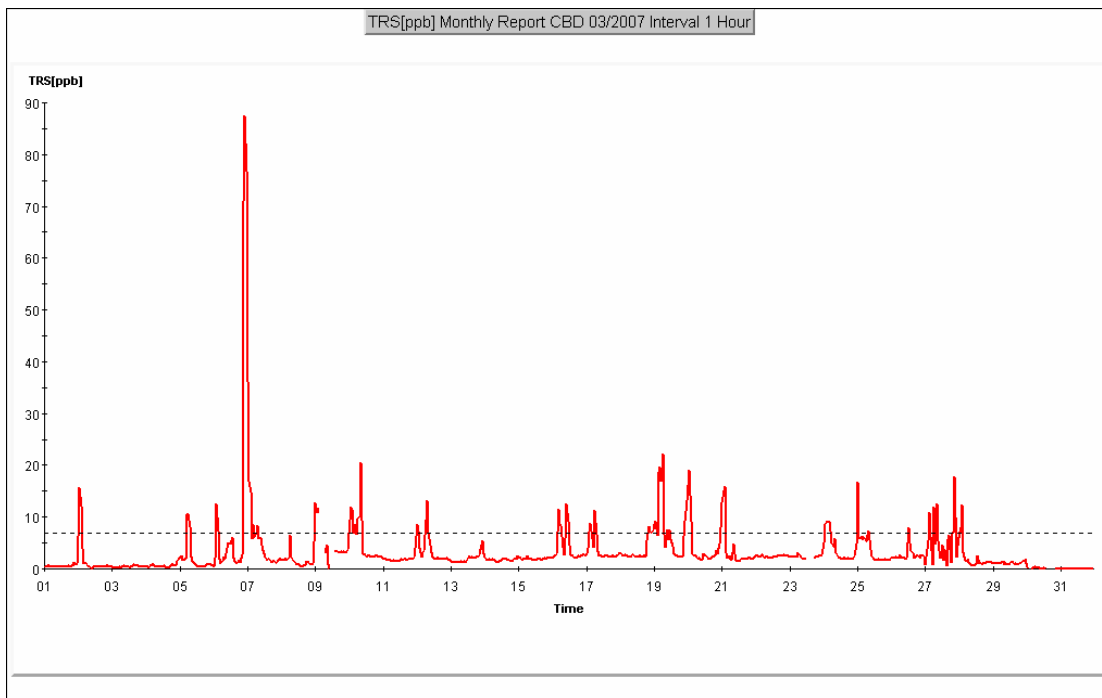
Figure 1: Hourly average TRS at the CBD station during March 2007

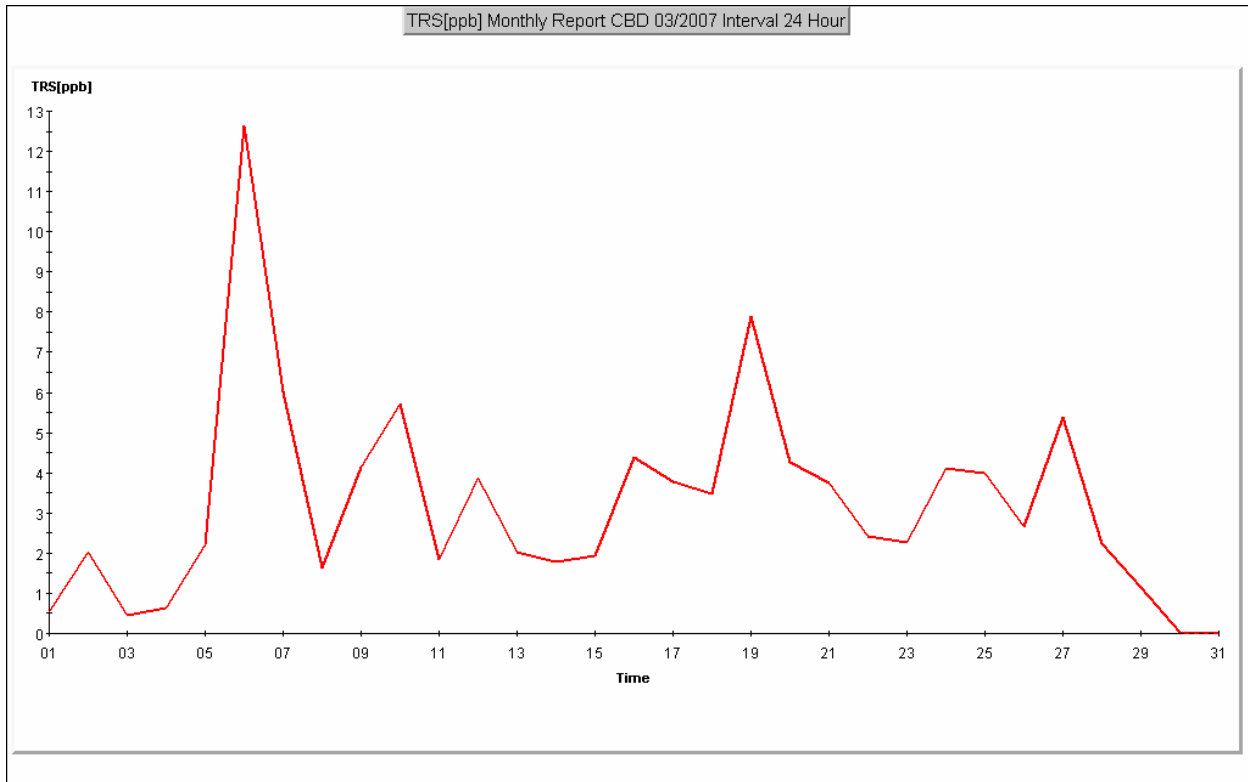
Figure 2: Daily average TRS at the CBD station during March 2007

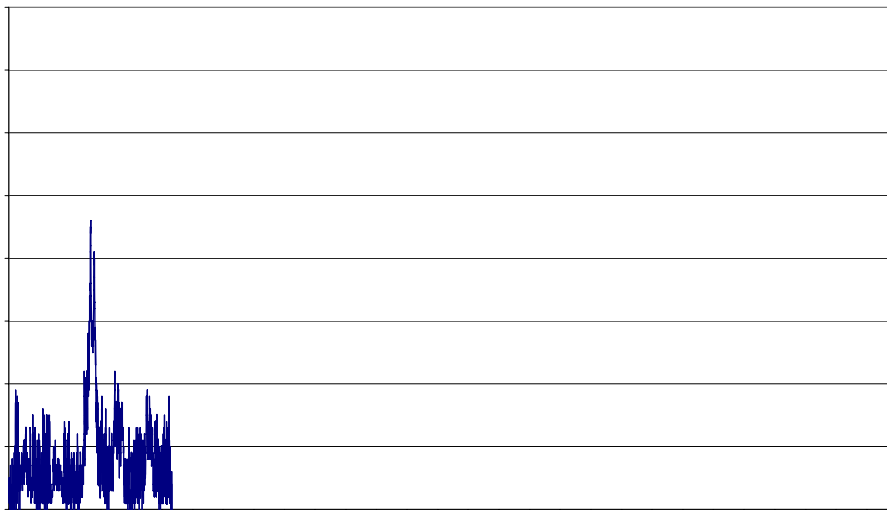
Figure 1: Average O₃ at Brackenhams during March 2007
