**RICHARDS BAY CLEAN AIR
ASSOCIATION
DUST DEPOSITION MONITORING
JUNE 2008**

**Sampling period: 19 May – 20 June 2008
Final Monthly Progress Report**

Date of Report: 07 July 2008
Report Number: AER 28.363 M_RBCAA

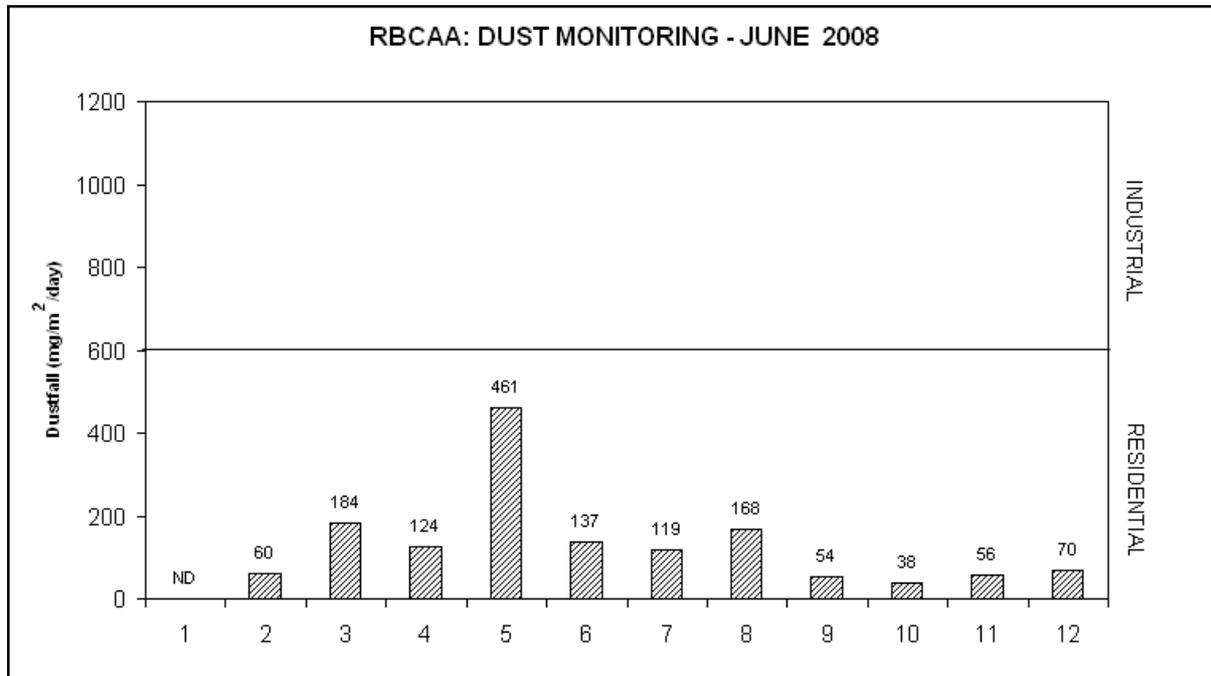
Figure 1: Graph showing results from all sites: June 2008

During the June 2008 reporting month, all the monitoring sites recorded dustfall rates within the RESIDENTIAL threshold, except Site 1 (Brackenhams) that recorded no data as the bucket was damaged. Trends of the dust fallout results per site are presented in Appendix A of this report.

RAND WATER DUSTFALL MONITORING			Month: June 2008 Sampling period: 19 May – 20 June 2008			
SITE DESCRIPTION	SITE CLASSIFICATION	SITE No.	FILTER CODE	NETT MASS (mg)	No. DAYS	DUST FALLOUT (mg/m ² /day)
Brackenham	RESIDENTIAL	1	RBCAA 08/133	ND	ND	ND
SAPS Garage	RESIDENTIAL	2	RBCAA 08/134	43	32	60
Alton South West	INDUSTRIAL	3	RBCAA 08/135	134	32	184
Harbour West	INDUSTRIAL	4	RBCAA 08/136	90	32	124
CBD(Municipal office)	RESIDENTIAL	5	RBCAA 08/137	334	32	461
Scorpio	INDUSTRIAL	6	RBCAA 08/138	99	32	137
Alton fire station	RESIDENTIAL	7	RBCAA 08/139	87	32	119
Nseleni Municipal office	RESIDENTIAL	8	RBCAA 08/140	122	32	168
Empangeni police station	RESIDENTIAL	9	RBCAA 08/141	40	32	54
Felixton Village	RESIDENTIAL	10	RBCAA 08/142	28	32	38
Arboretum	INDUSTRIAL	11	RBCAA 08/143	41	32	56
Meerensee School	RESIDENTIAL	12	RBCAA 08/144	51	32	70

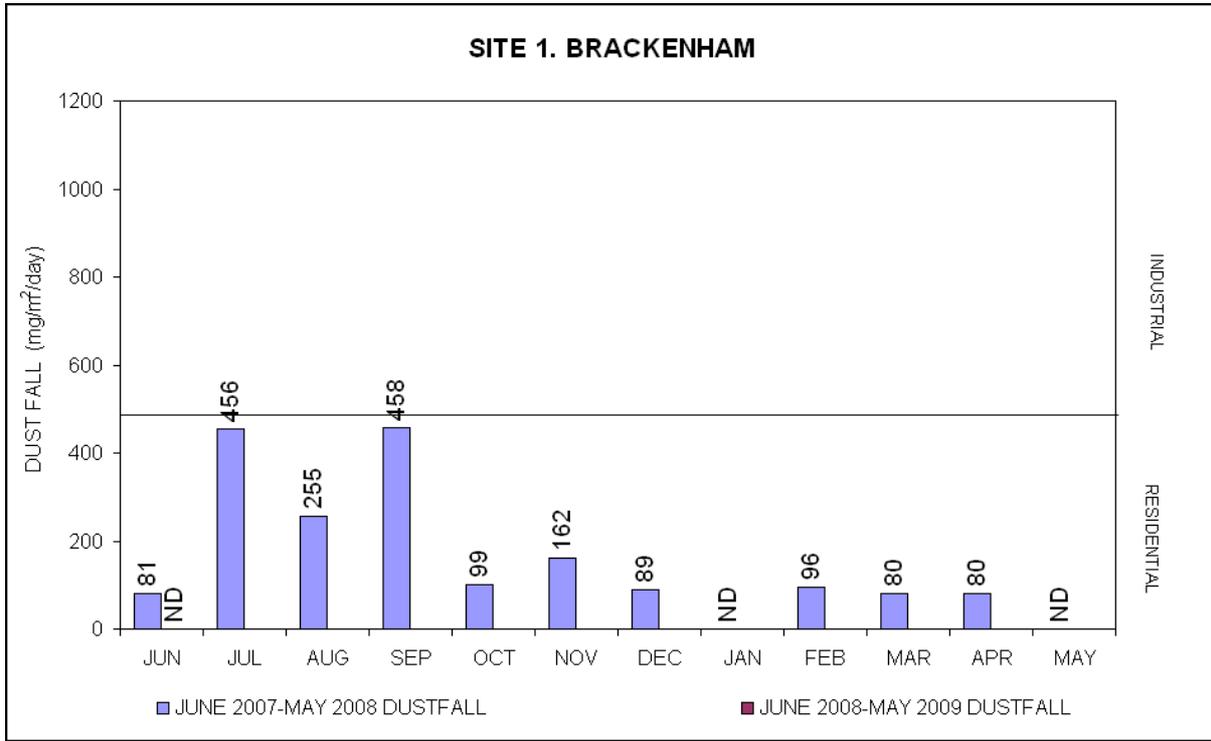
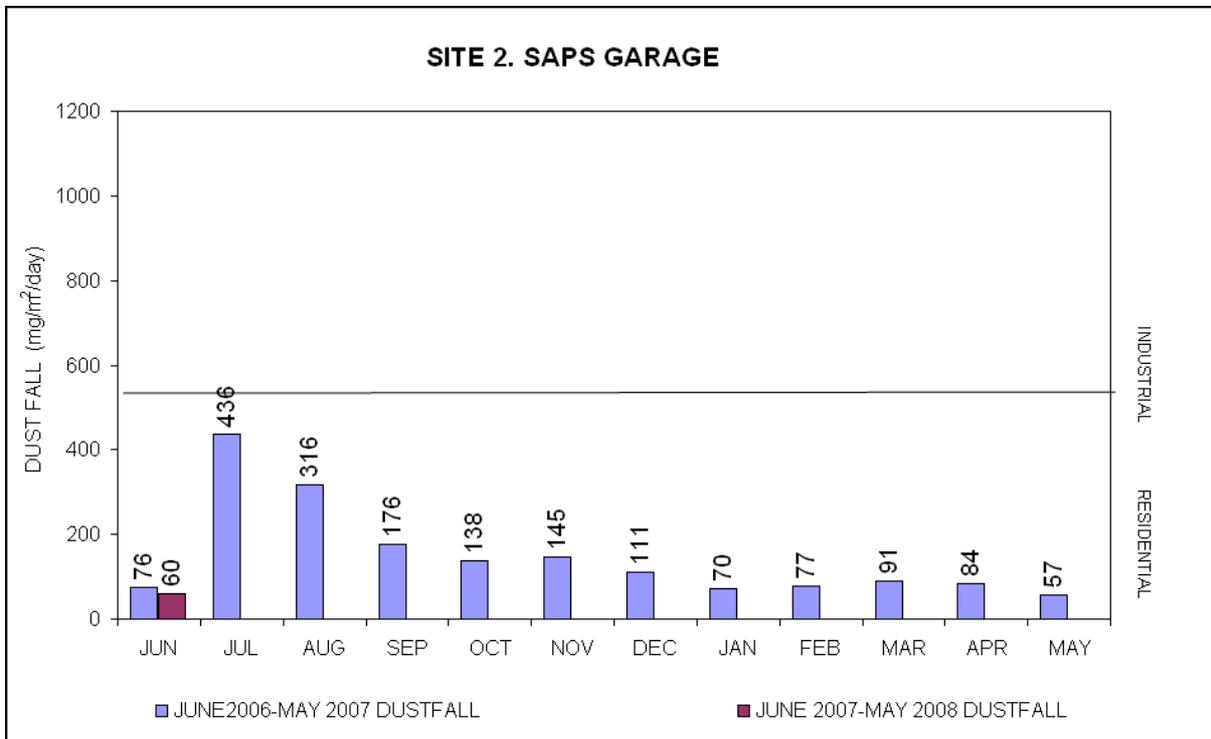
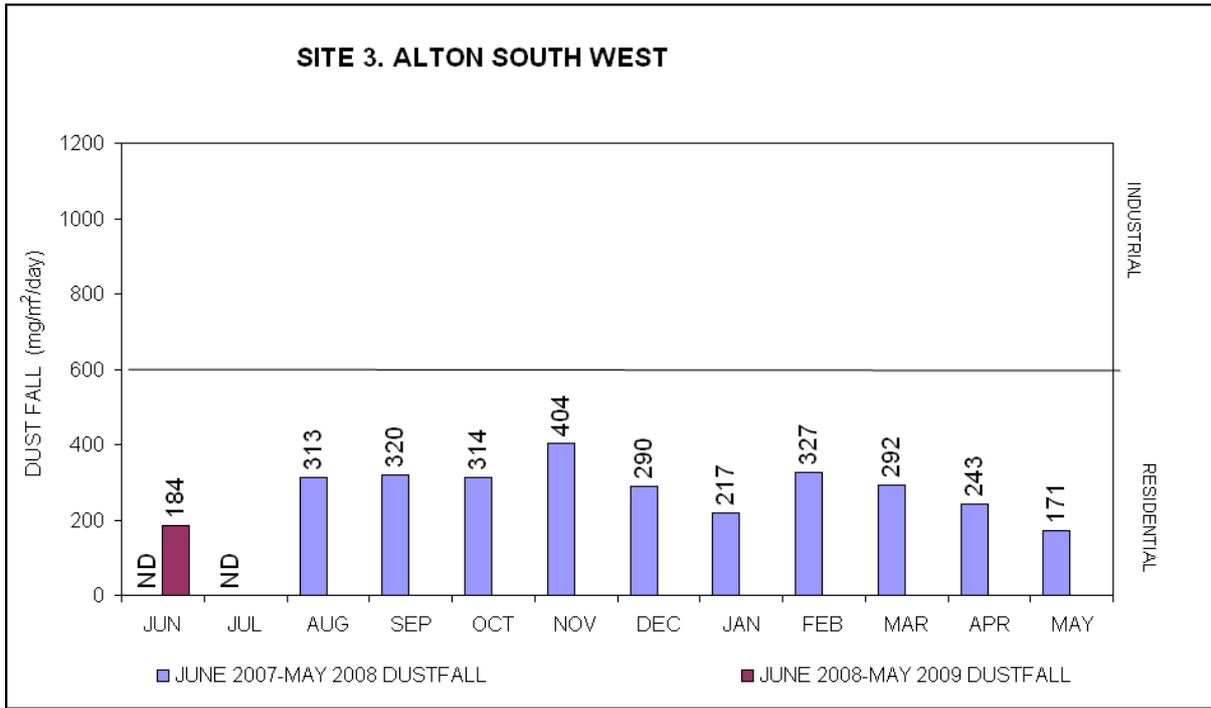
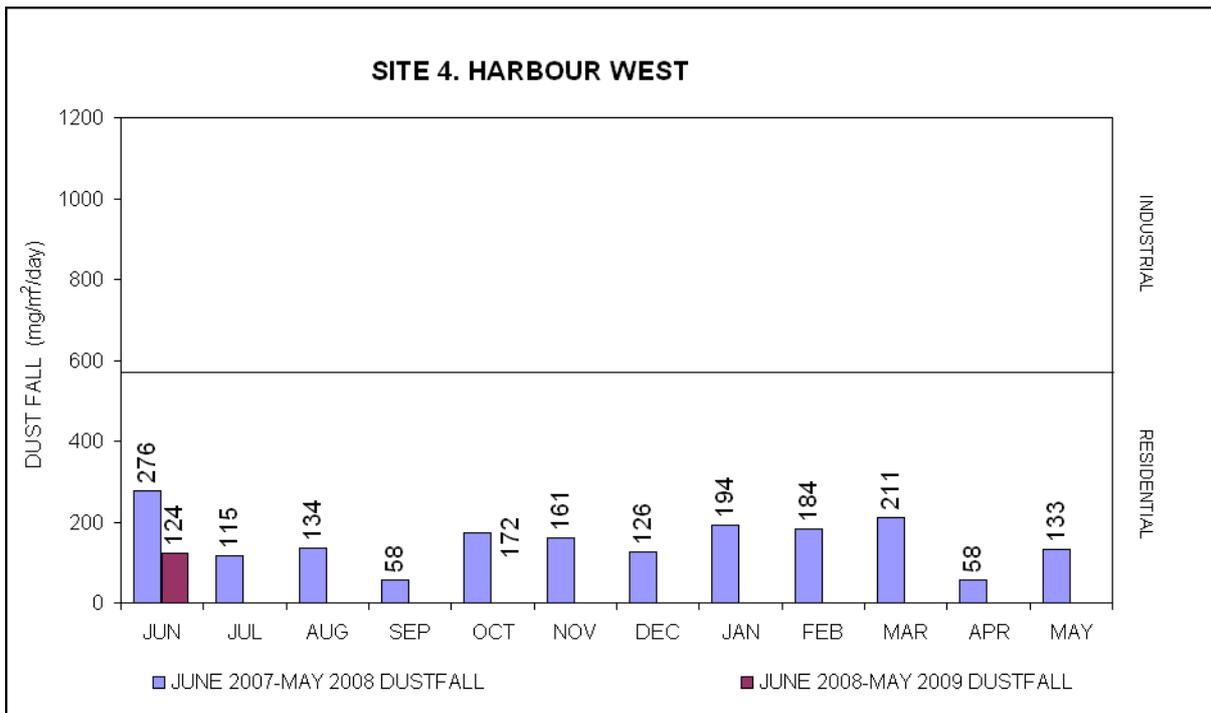
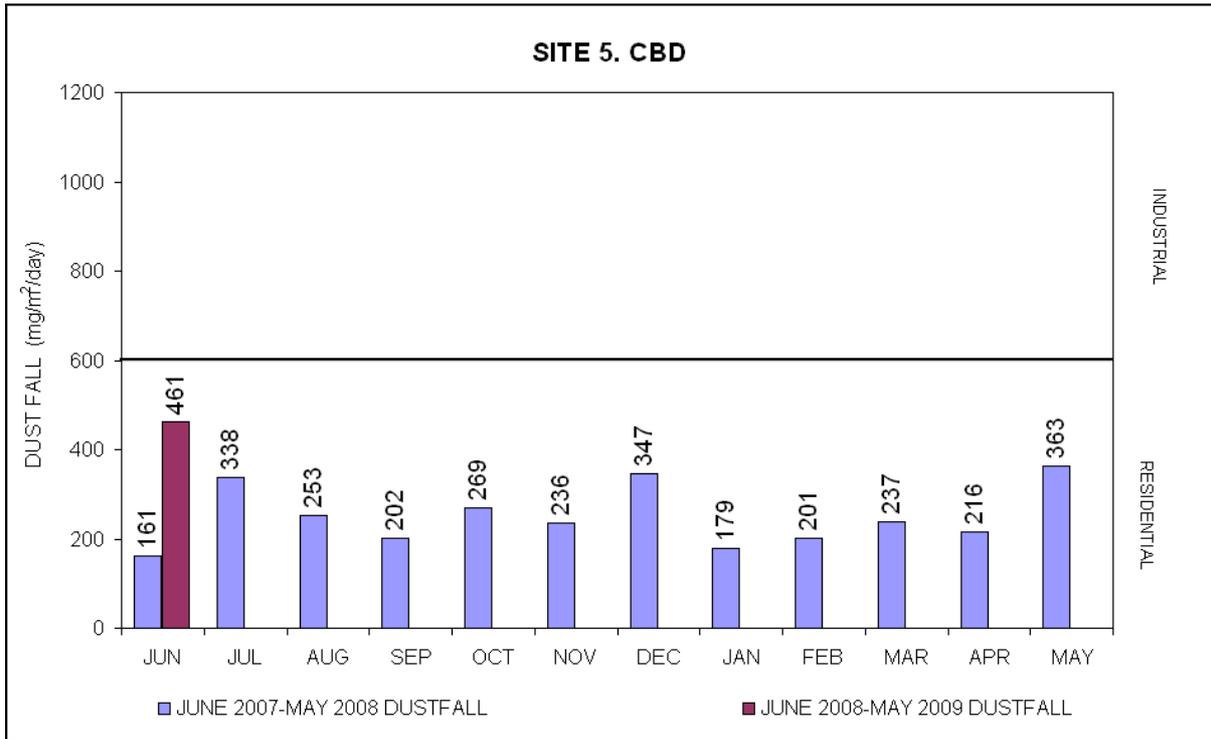
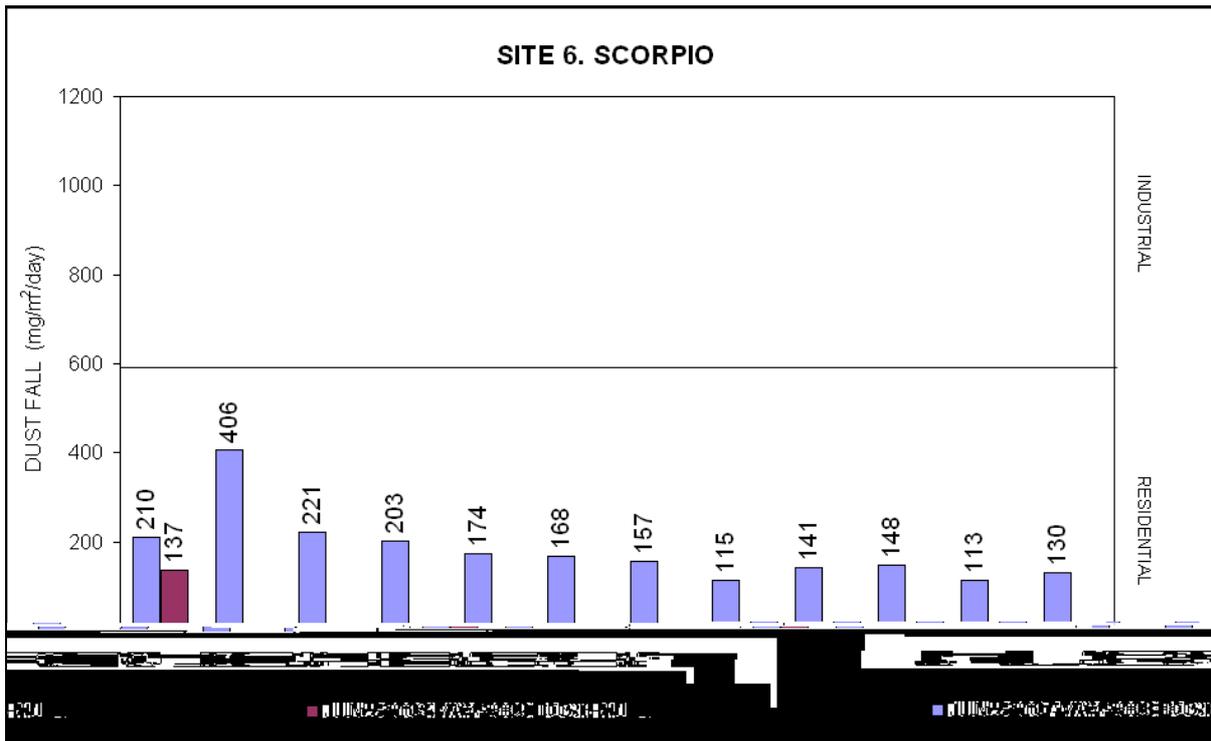
APPENDIX A RBCAA DUST FALLOUT MONTHLY TIMEPLOTS 2006 – 2008
