**RICHARDS BAY CLEAN AIR
ASSOCIATION
DUST DEPOSITION MONITORING
FEBRUARY 2009**

**Sampling period: 15 January – 17 February 2009
Final Monthly Progress Report**

Date of Report: 11 March 2009
Report Number: AER 29.101 M_RBCAA

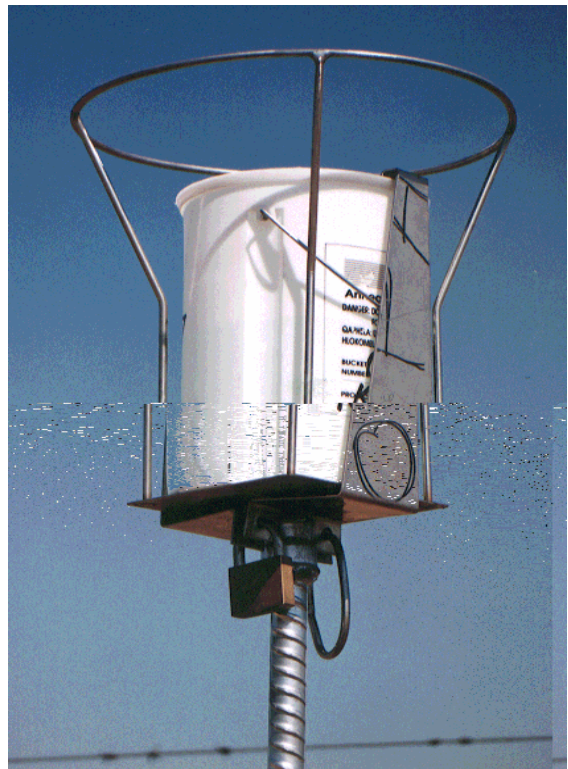
Figure 1: Single bucket monitoring unit, showing sampling bucket with bird ring and security clamp.

The bucket stand comprises a ring that is raised above the rim of the bucket to prevent contamination from perching birds (Fig 1). The bucket holder is connected to a 2.1 m galvanized steel pole, which is either directly attached to a fence post or can be attached to a galvanized steel base plate, which is buried to a depth of 500 mm. This allows for a variety of placement options for the fallout samplers. Exposed buckets, when returned to the AER laboratories, are rinsed with deionised water to remove residue from the sides of the bucket, and the bucket contents filtered through a coarse ($>1\text{mm}$) filter to remove insects and other coarse organic detritus. The sample is then filtered through a pre-weighed paper filter to remove the insoluble fraction, or dust fallout. This residue and filter are dried, and gravimetrically analysed to determine the insoluble fraction (dust fallout).

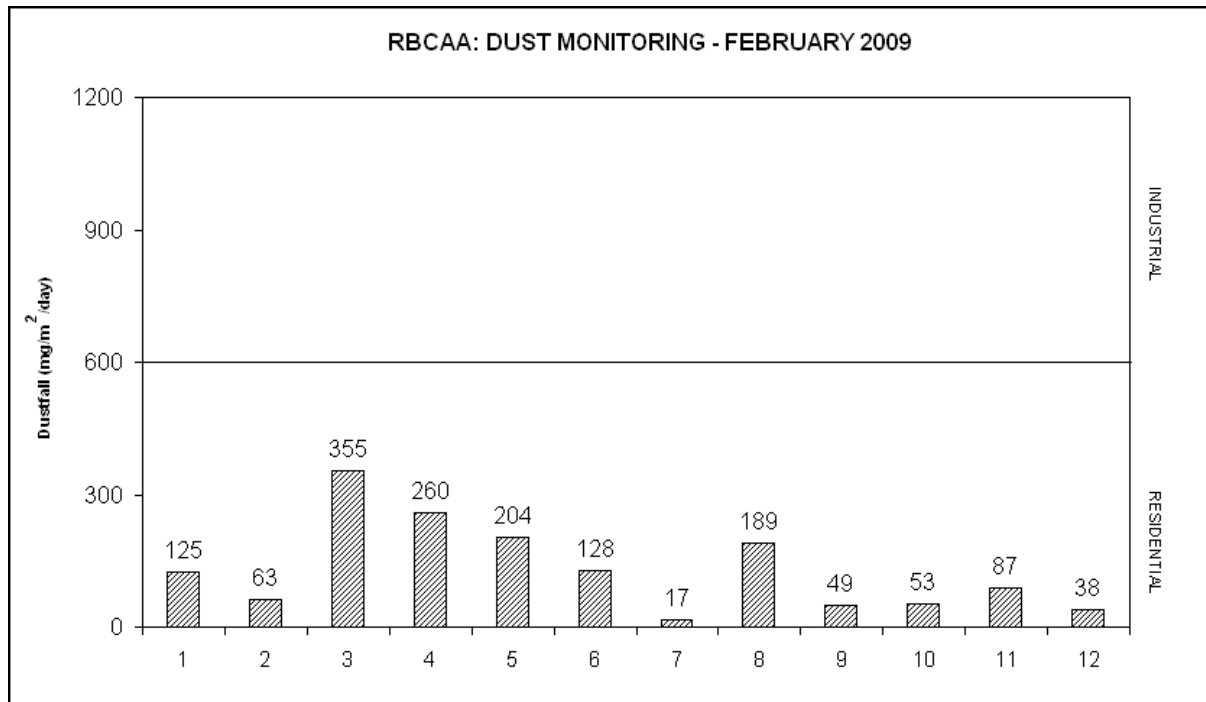
Figure 1: Graph showing results from all sites: February 2009

- All the monitoring sites recorded RESIDENTIAL threshold levels and the results are considered satisfactory as they will not result in community complaints or nuisance.
- Site 2 (SAPS Garage) recorded one incident ACTION dustfall rate and is

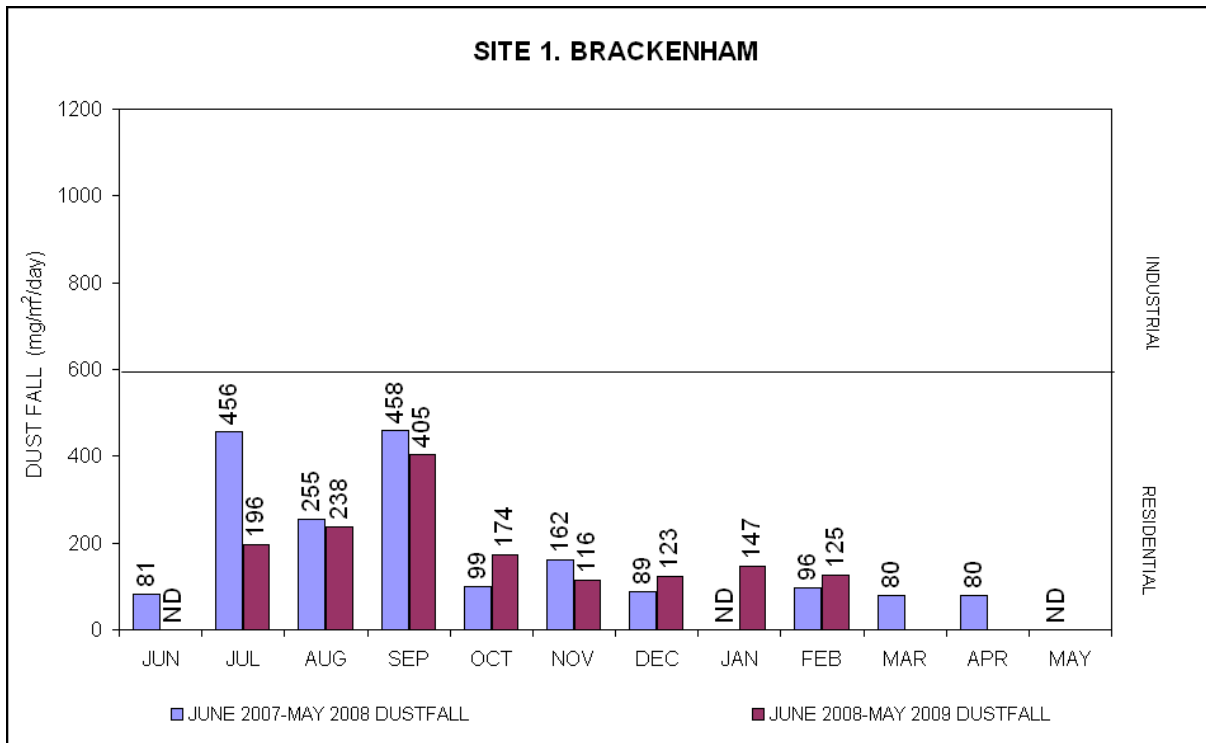
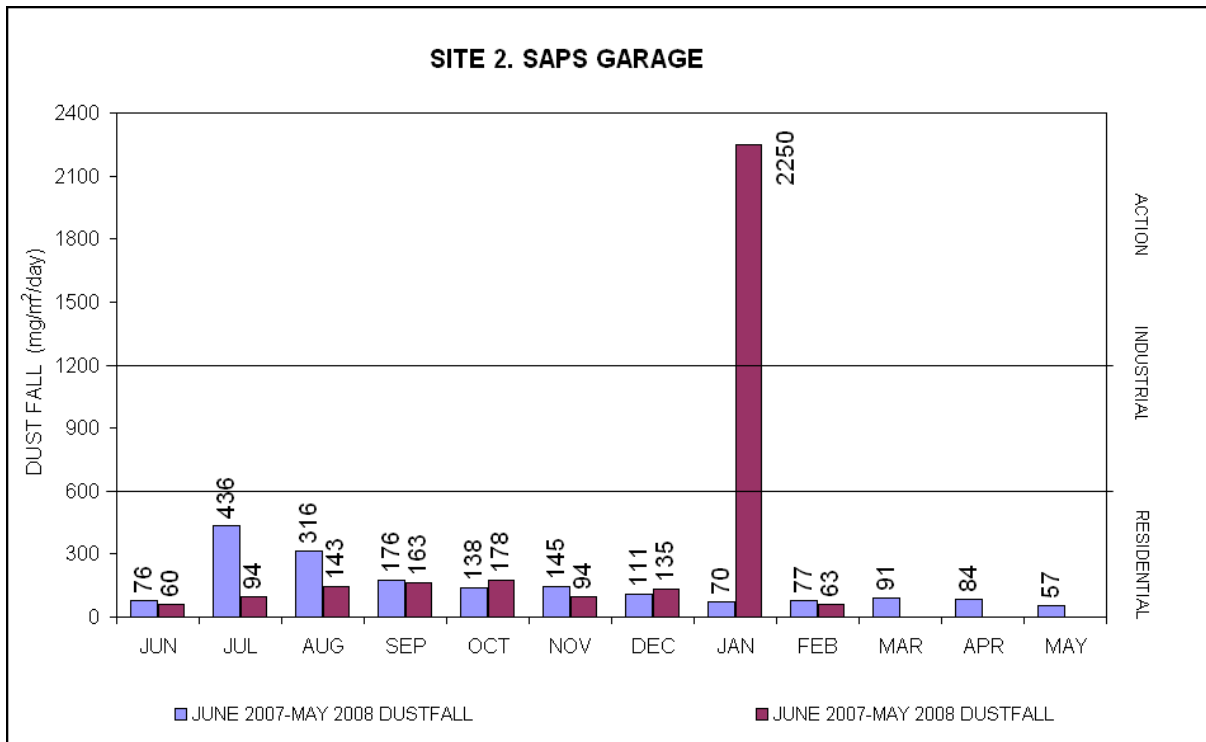
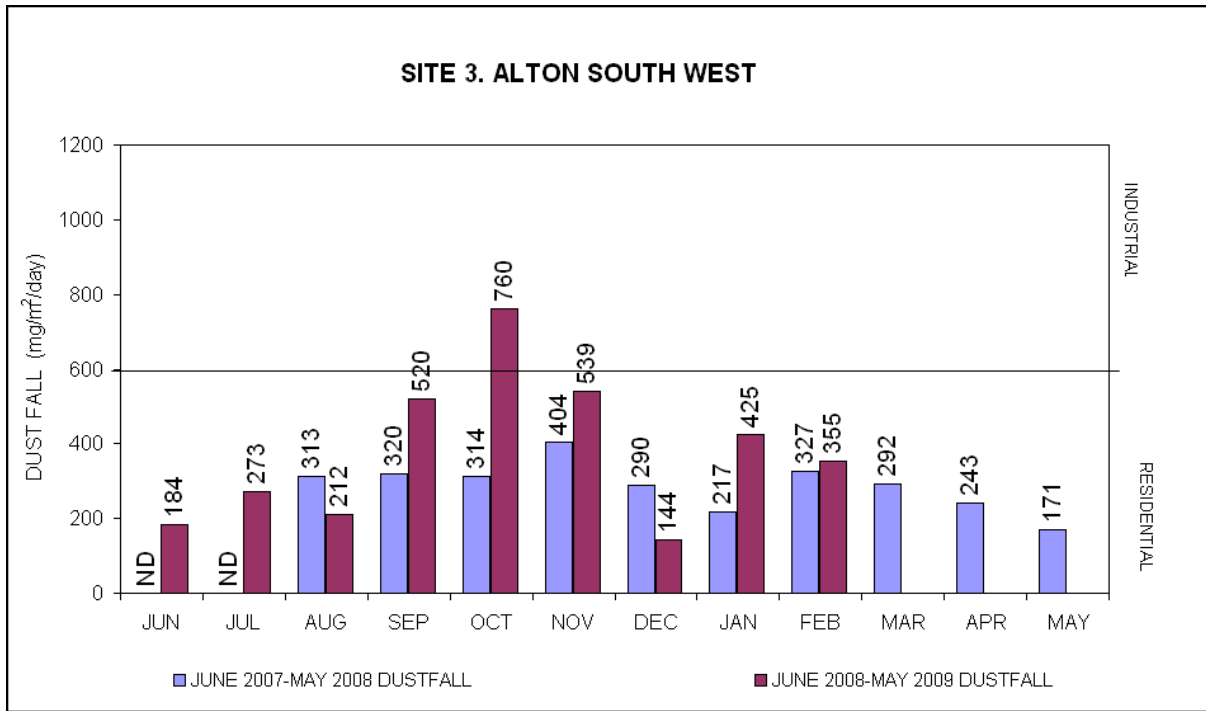
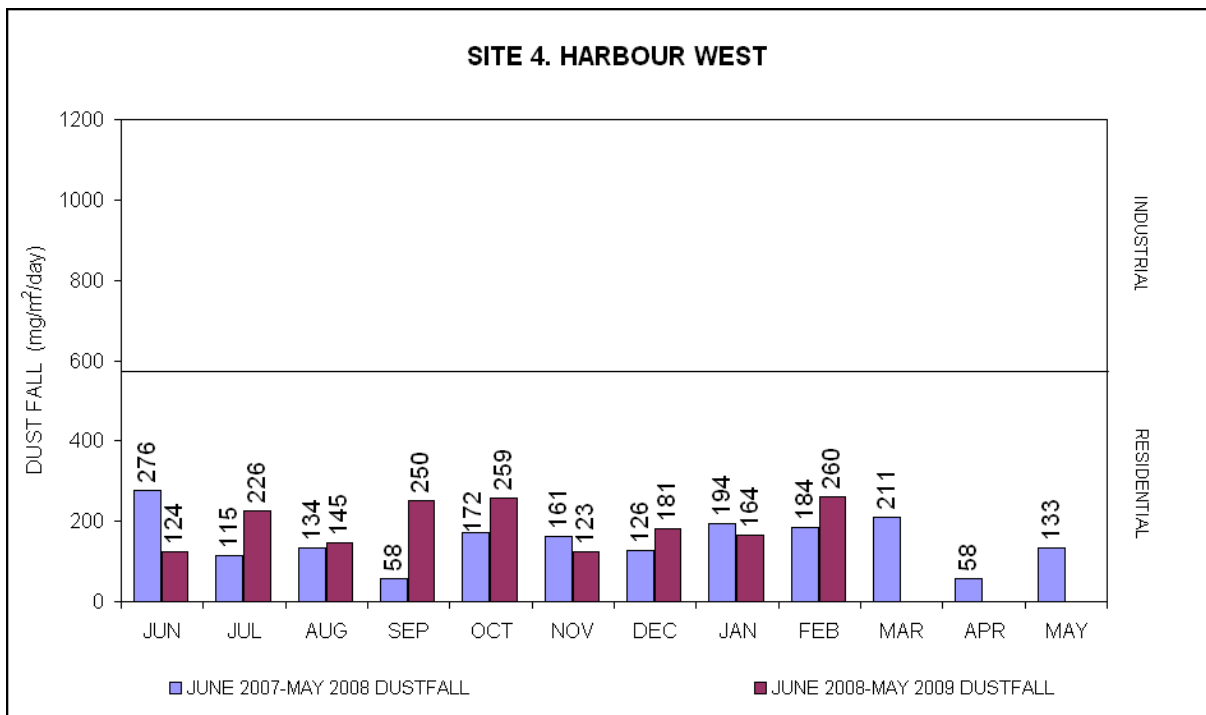
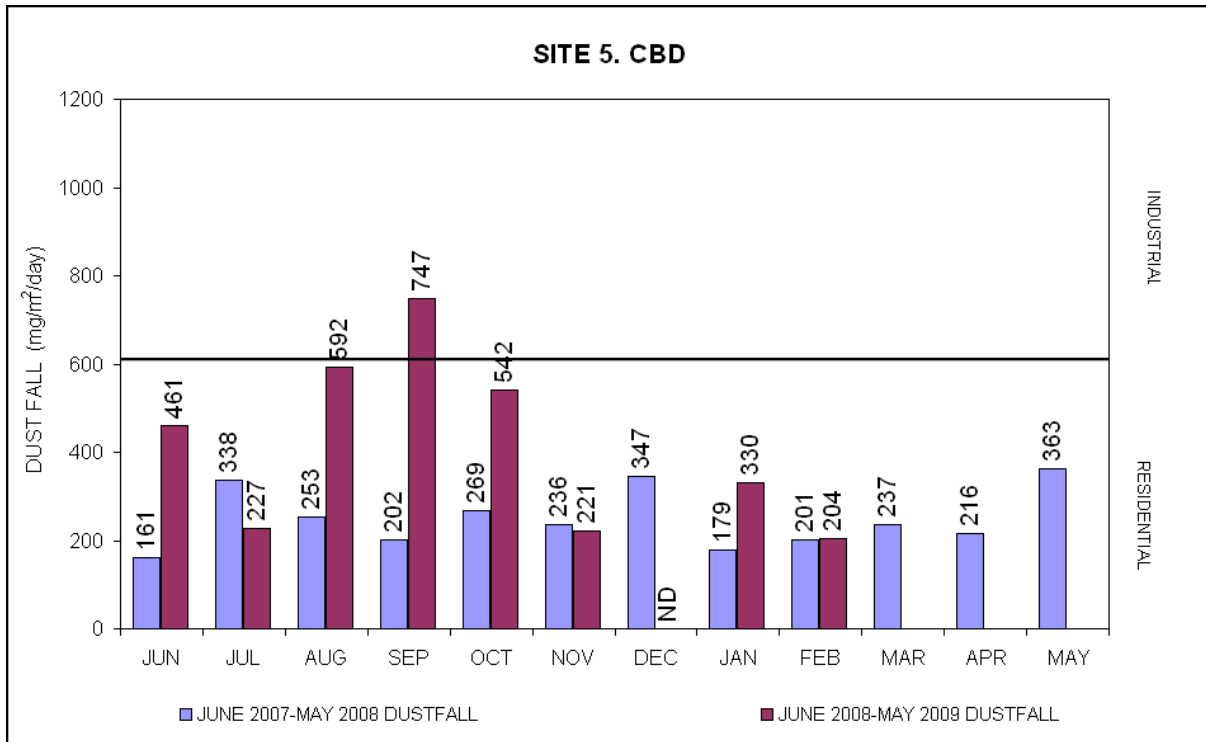
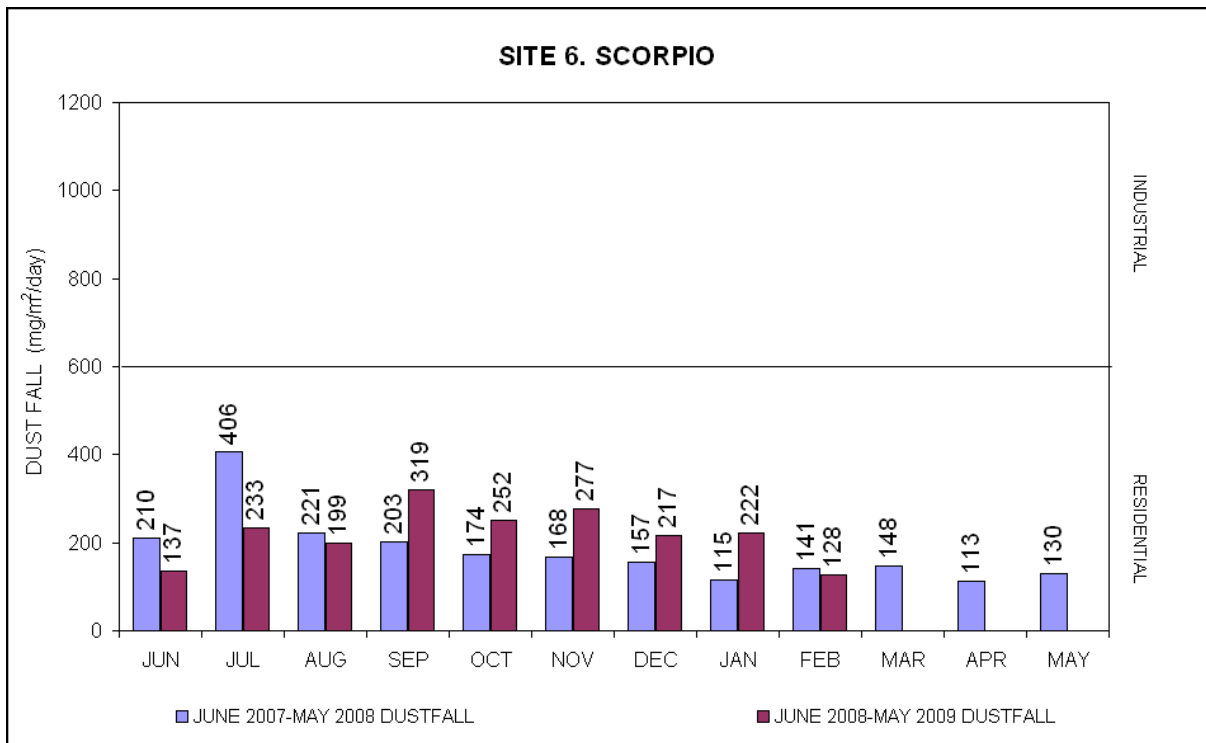
APPENDIX A RBCAA DUST FALLOUT MONTHLY TIMEPLOTS 2007 – 2009
