**RICHARDS BAY CLEAN AIR  
ASSOCIATION  
DUST DEPOSITION MONITORING  
AUGUST 2008**

**Sampling period: 18 July – 19 August 2008  
Final Monthly Progress Report**

Date of Report: 04 September 2008  
Report Number: AER 28.490 M\_RBCAA

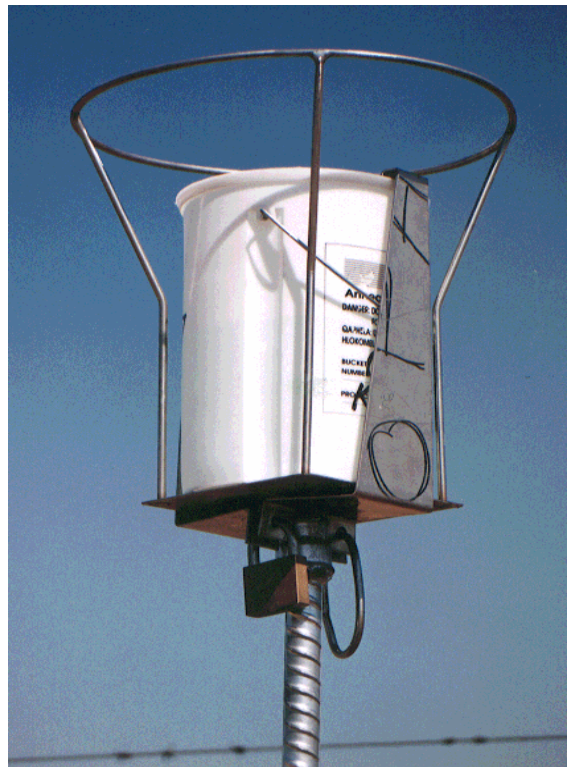
The bucket stand comprises a ring that is raised above the rim of the bucket to prevent contamination from perching birds (Fig 1). The bucket holder is connected to a 2.1 m galvanized steel pole, which is either directly attached to a fence post or can be attached to a galvanized steel base plate, which is buried to a depth of 500 mm. This allows for a variety of placement options for the fallout samplers. Exposed buckets, when returned to the AER laboratories, are rinsed with deionised water to remove residue from the sides of the bucket, and the bucket contents filtered through a coarse ( $>1\text{mm}$ ) filter to remove insects and other coarse organic detritus. The sample is then filtered through a pre-weighed paper filter to remove the insoluble fraction, or dust fallout. This residue and filter are dried, and gravimetrically analysed to determine the insoluble fraction (dust fallout).

Figure 1: Single bucket monitoring unit, showing sampling bucket with bird ring and security clamp.

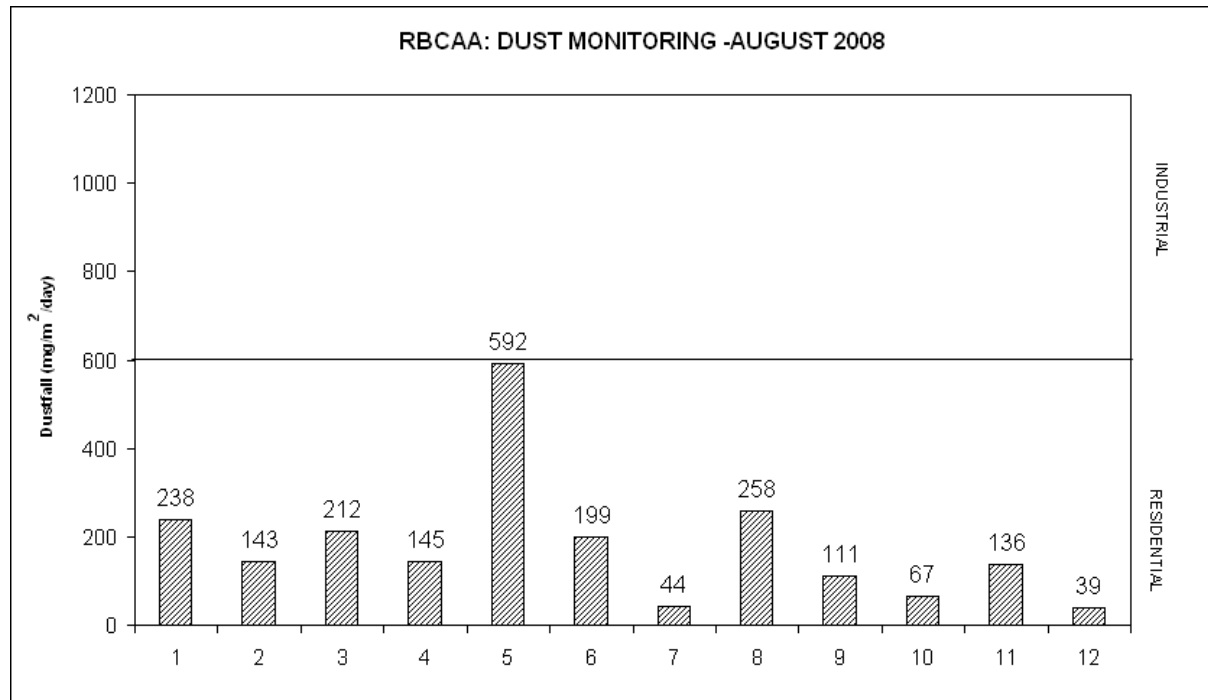
During the August 2008 reporting month, all the monitoring sites recorded dustfall rates within the RESIDENTIAL threshold. However, site 5 (CBD(Municipal office) recorded the highest dustfall of 592 mg/m<sup>2</sup>/day, due to construction taking place close to the site. Trends of the dust fallout results per site are presented in Appendix A of this report.

**Figure 1: Graph showing results from all sites: August 2008**

- RESIDENTIAL threshold levels were recorded at all the monitoring sites.
- The results are considered satisfactory as they will not result in community complaints or nuisance.
- All twelve sites complied with the SANS targets as laid out in section 2.
