**RICHARDS BAY CLEAN AIR
ASSOCIATION
DUST DEPOSITION MONITORING
SEPTEMBER 2008**

**Sampling period: 19 August – 18 September 2008
Final Monthly Progress Report**

Date of Report: 13 October 2008
Report Number: AER 28.554 M_RBCAA

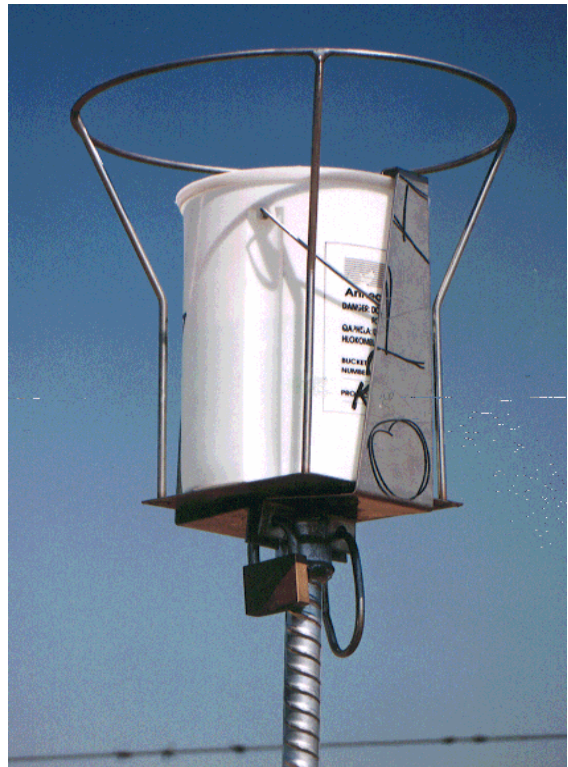
Figure 1: Single bucket monitoring unit, showing sampling bucket with bird ring and security clamp.

The bucket stand comprises a ring that is raised above the rim of the bucket to prevent contamination from perching birds (Fig 1). The bucket holder is connected to a 2.1 m galvanized steel pole, which is either directly attached to a fence post or can be attached to a galvanized steel base plate, which is buried to a depth of 500 mm. This allows for a variety of placement options for the fallout samplers. Exposed buckets, when returned to the AER laboratories, are rinsed with deionised water to remove residue from the sides of the bucket, and the bucket contents filtered through a coarse ($>1\text{mm}$) filter to remove insects and other coarse organic detritus. The sample is then filtered through a pre-weighed paper filter to remove the insoluble fraction, or dust fallout. This residue and filter are dried, and gravimetrically analysed to determine the insoluble fraction (dust fallout).

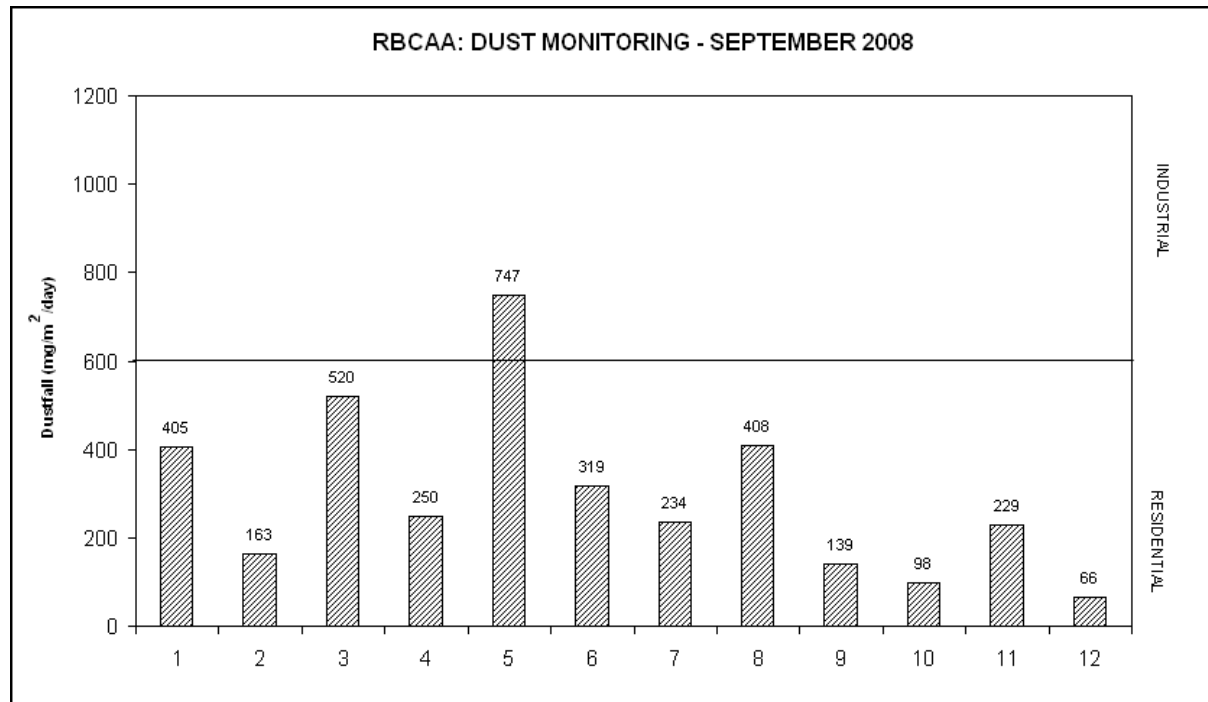
Figure 1: Graph showing results from all sites: September 2008

Site 5 (CBD(Municipal office)) recorded INDUSTRIAL dustfall rates of **747** (mg/m²/day) during the September 2008 reporting month due to construction taking place close to the site. The remaining monitoring sites recorded dustfall rates within the RESIDENTIAL threshold. Trends of the dust fallout results per site are presented in Appendix A of this report.

Comment: * There is construction going around Site 5 (CBD –Municipal office)
