**RICHARDS BAY CLEAN AIR
ASSOCIATION
DUST DEPOSITION MONITORING
MARCH 2009**

**Sampling period: 17 February – 16 March 2009
Final Monthly Progress Report**

Date of Report: 14 April 2009
Report Number: AER 29.169 M_RBCAA

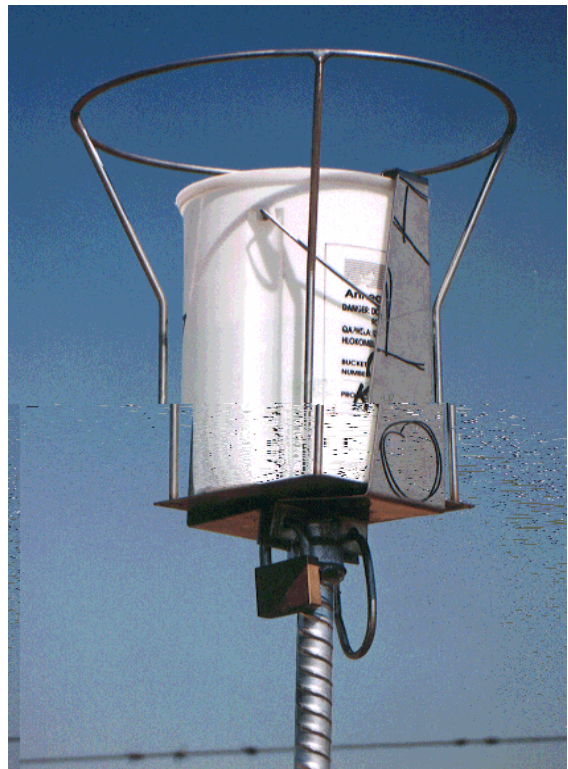
Figure 1: Single bucket monitoring unit, showing sampling bucket with bird ring and security clamp.

The bucket stand comprises a ring that is raised above the rim of the bucket to prevent contamination from perching birds (Fig 1). The bucket holder is connected to a 2.1 m galvanized steel pole, which is either directly attached to a fence post or can be attached to a galvanized steel base plate, which is buried to a depth of 500 mm. This allows for a variety of placement options for the fallout samplers. Exposed buckets, when returned to the AER laboratories, are rinsed with deionised water to remove residue from the sides of the bucket, and the bucket contents filtered through a coarse ($>1\text{mm}$) filter to remove insects and other coarse organic detritus. The sample is then filtered through a pre-weighed paper filter to remove the insoluble fraction, or dust fallout. This residue and filter are dried, and gravimetrically analysed to determine the insoluble fraction (dust fallout).

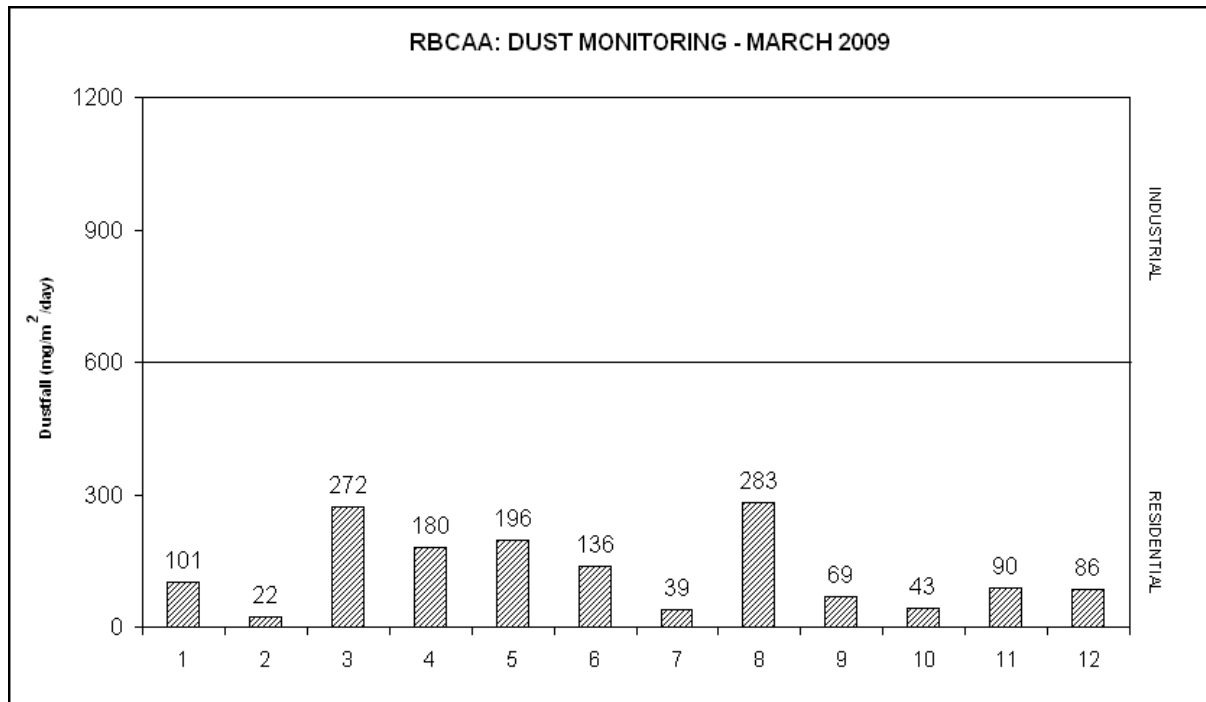
Figure 1: Graph showing results from all sites: March 2009

All the monitoring sites recorded dustfall rates within the RESIDENTIAL threshold. Trends of the dust fallout results per site are presented in Appendix A of this report.
