**RICHARDS BAY CLEAN AIR
ASSOCIATION
DUST DEPOSITION MONITORING
JUNE 2009
Sampling period: 18 May – 17 June 2009
Final Monthly Progress Report**

Project Leader: H.J. Annegarn
Project Officers: L. Khumalo
T. Masethe

Date of Report: 07 July 2009
Report Number: AER 29.347 M_RBCAA

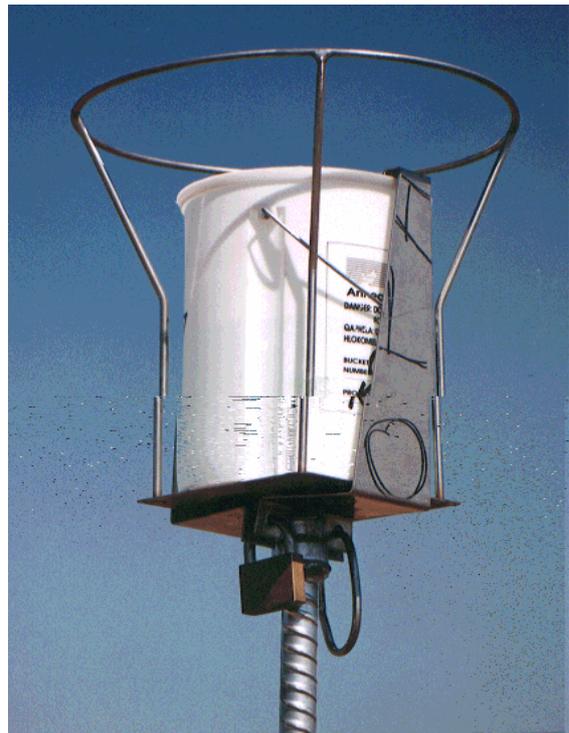
The bucket stand comprises a ring that is raised above the rim of the bucket to prevent contamination from perching birds (Fig 1). The bucket holder is connected to a 2.1 m galvanized steel pole, which is either directly attached to a fence post or can be attached to a galvanized steel base plate, which is buried to a depth of 500 mm. This allows for a variety of placement options for the fallout samplers. Exposed buckets, when returned to the AER laboratories, are rinsed with deionised water to remove residue from the sides of the bucket, and the bucket contents filtered through a coarse ($>1\text{mm}$) filter to remove insects and other coarse organic detritus. The sample is then filtered through a pre-weighed paper filter to remove the insoluble fraction, or dust fallout. This residue and filter are dried, and gravimetrically analysed to determine the insoluble fraction (dust fallout).

Figure 1: Single bucket monitoring unit, showing sampling bucket with bird ring and security clamp.

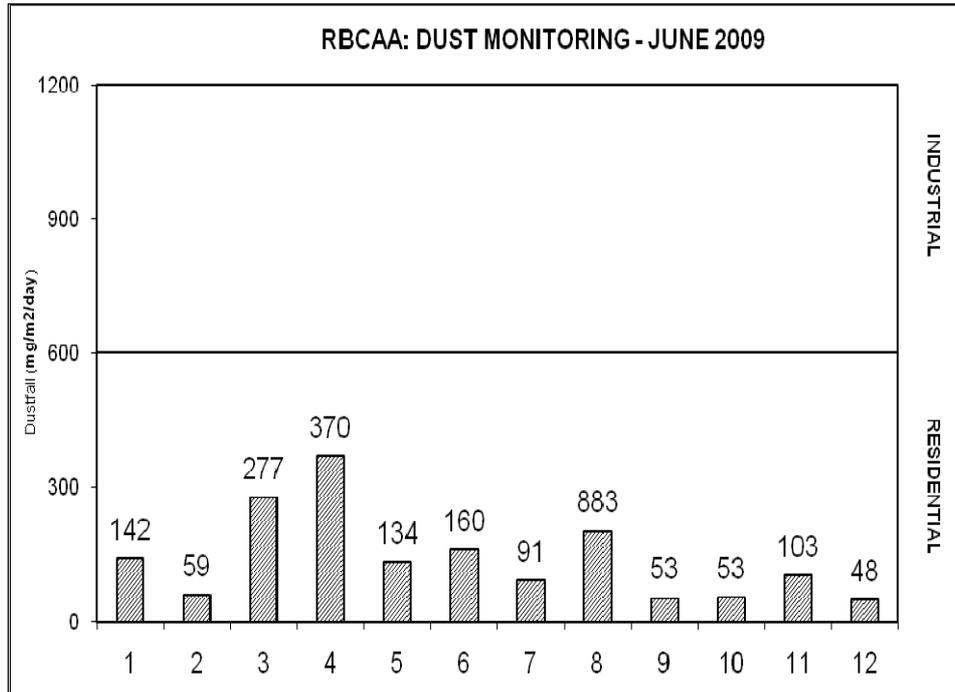
During the June 2009 reporting month, all the monitoring sites recorded dustfall rates within the RESIDENTIAL threshold. Site 4 (Harbour west station) recorded the highest dustfall of 370 mg/m²/day, due to high volume of moving vehicles closer to the site as a result of Transnet permit office which is now located nearby the site. Trends of the dust fallout results per site are presented in Appendix A of this report.

Figure 1: Graph showing results from all sites: June 2009
